# **The state of the coast - Toestand van de Kust -**

**Case study: Wadden islands**

1220040-004

**Title**  
 The state of the coast  
 - Toestand van de Kust -

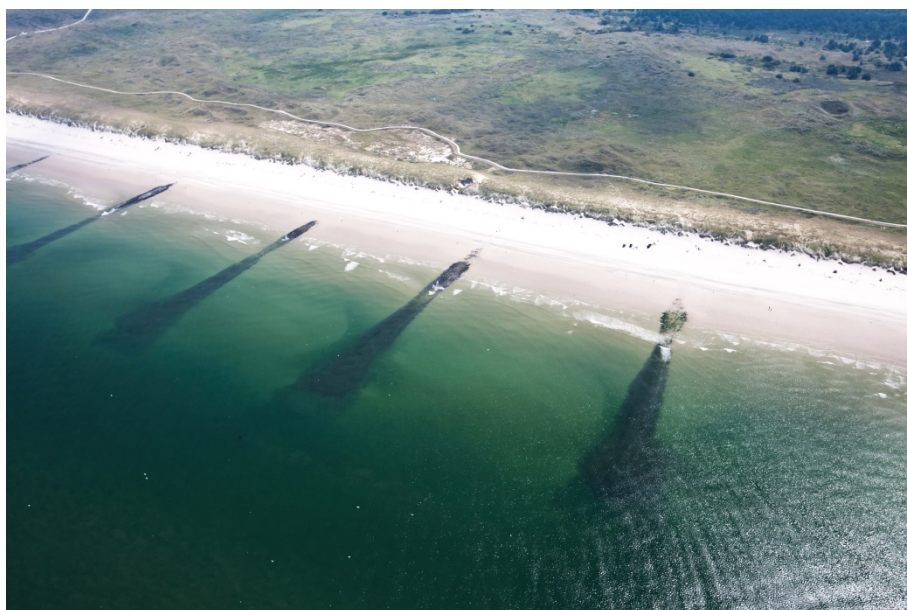
Figure 5.1 Groyne at Vlieland, in front of beach with vegetated dunes.

However, most of the groynes and revetments have been built since around 1800 (Figure 5.1). As an example, Figure 5.2 shows how the island of Ameland and the man-made coastal protection works have changed between 1665 and now. In 1665, coastal defences in the form of dunes were surrounding the villages of Hollum and Ballum, and Nes and Buren. Two dikes were connecting the two dune systems. However, the rest of the island was still free from structures and open to natural developments. Nowadays, dunes and dikes surround almost completely the island. An overview of all structures for each of the islands is given in Appendix B.

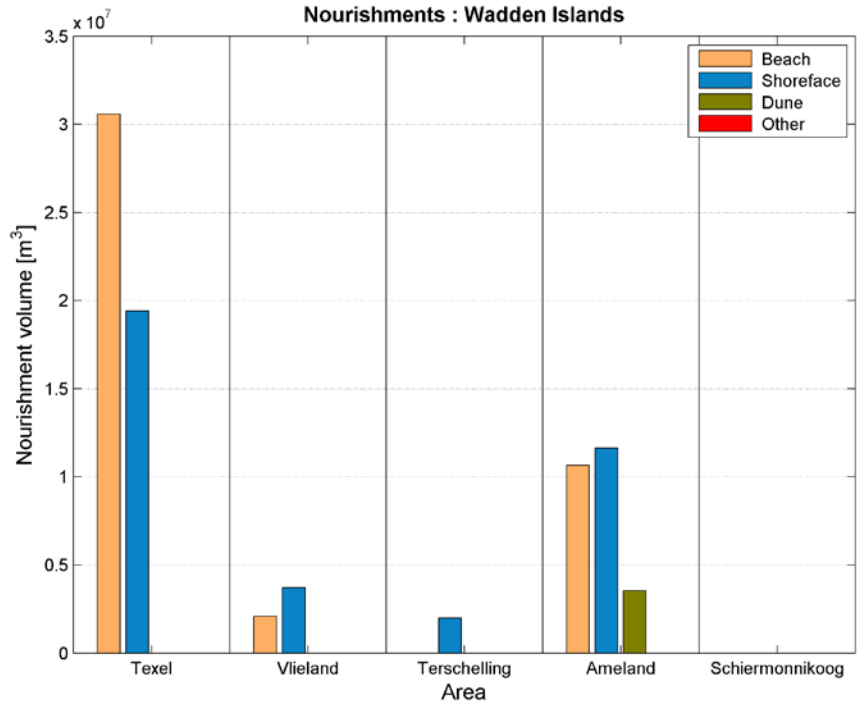
Figure 5.5 Total volume of nourishments applied in the Wadden islands. Sub-division per region and type.

The first beach nourishments on the Dutch Wadden islands were built in 1979 at Texel and Ameland. Since then, a considerable amount of sand was used in the form of beach and shoreface nourishments. The total volume of nourishments placed on the islands is given in Figure 5.5, with sub-division per island (“kustvak”) and type. The nourishment volumes at each island and subdivided for each Jarkus transect are given in Figure 5.6 - Figure 5.9. The largest amount of nourishments have been applied at Texel and Ameland, while Schiermonnikoog has never been nourished. Nourishment volumes show a general even sub-division between shoreface and beach nourishments. This differs from the other Dutch Delta (the South-Westerly Delta), where the distribution is much more skewed towards beach nourishments.

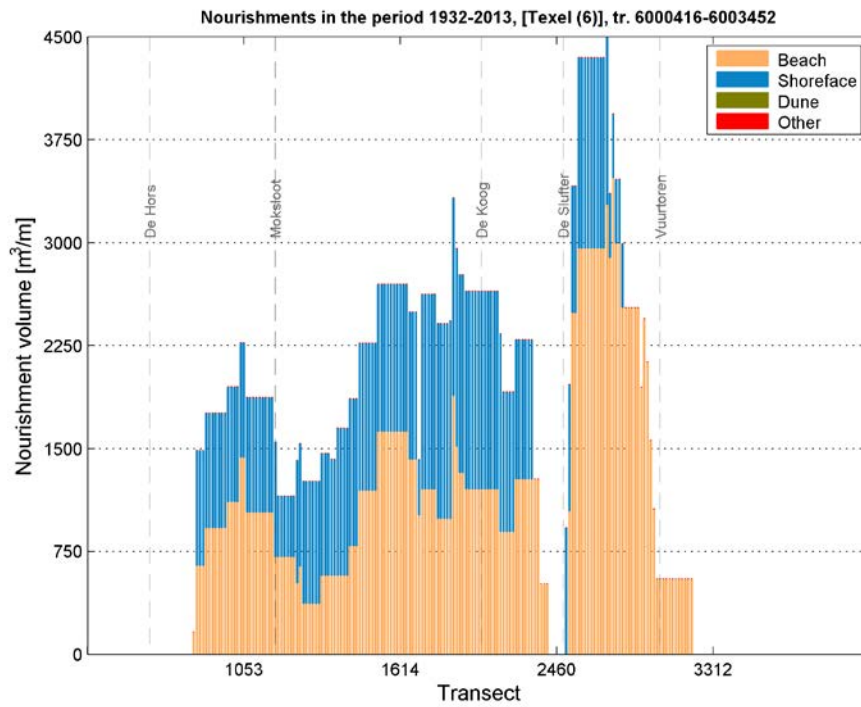
Figure 5.6 Total volume of nourishments in Texel. Sub-division per region and type.

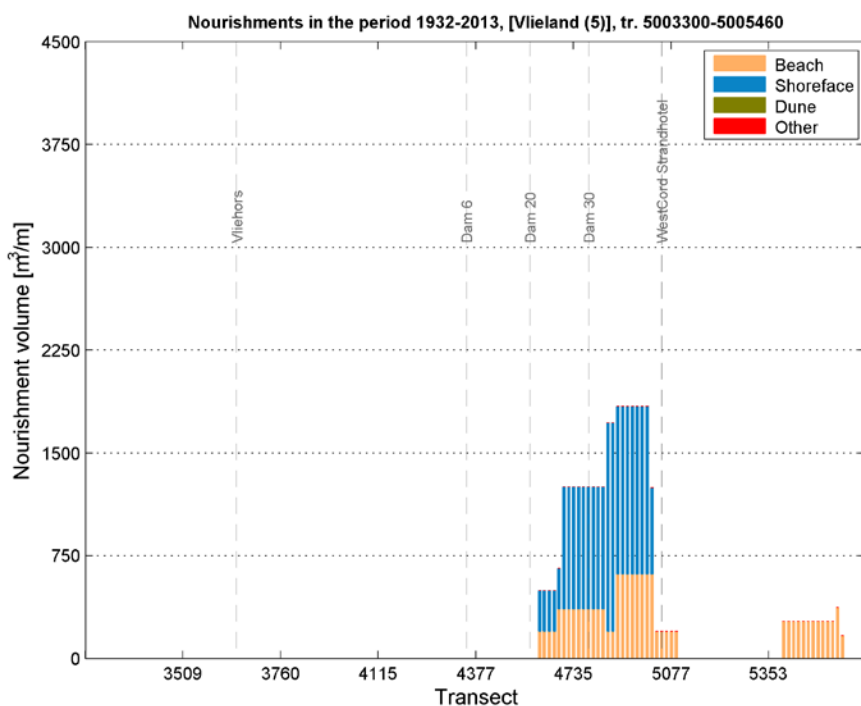
Figure 5.7 Total volume of nourishments in Vlieland. Sub-division per region and type.

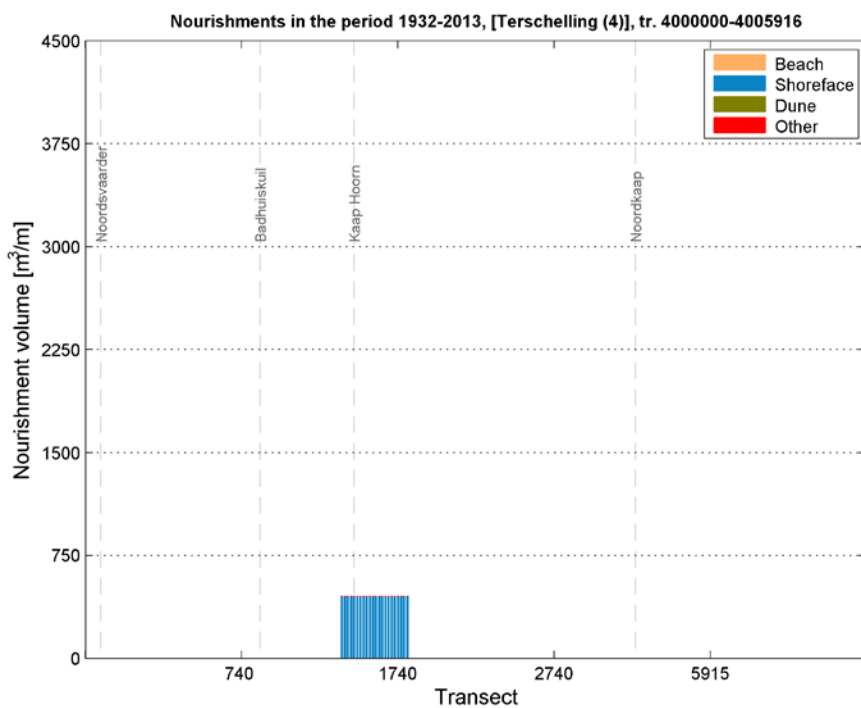
Figure 5.8 Total volume of nourishments in Terschelling. Sub-division per region and type.

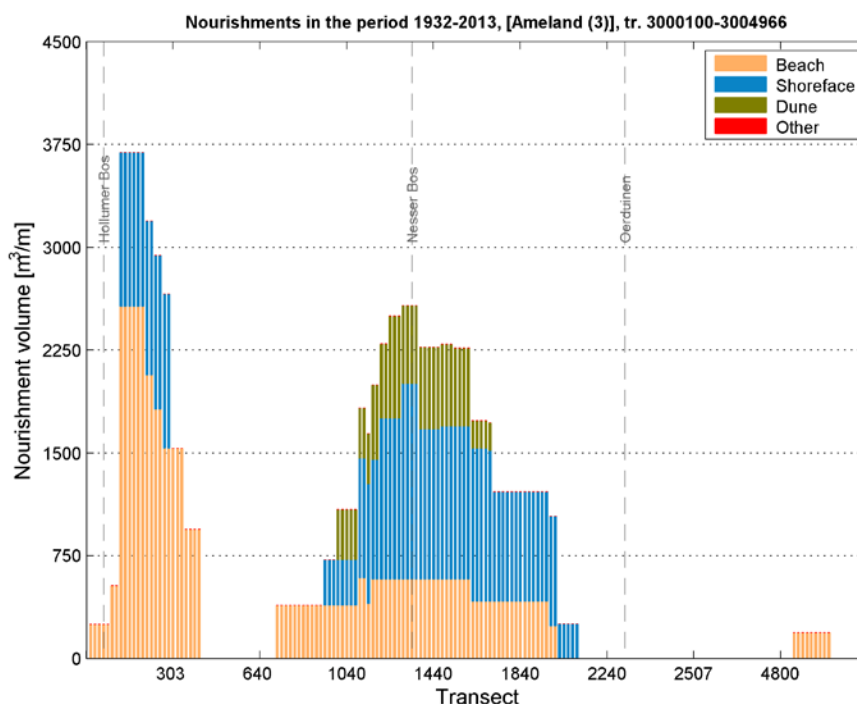
Figure 5.9 Total volume of nourishments in Ameland. Sub-division per region and type.

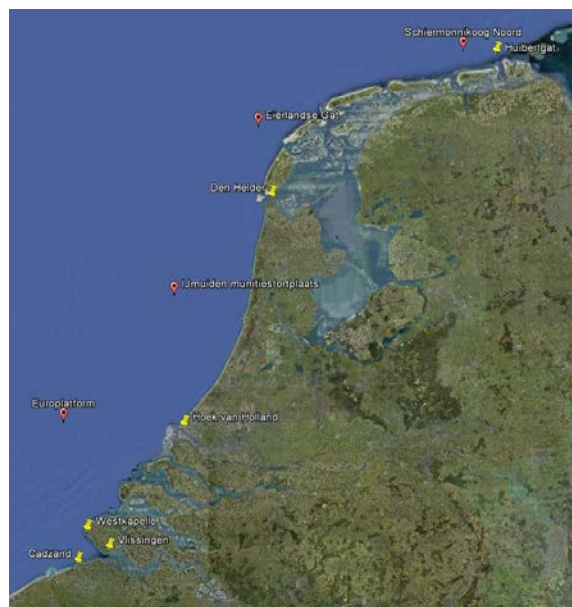
Figure 6.1 Location water level stations (in yellow) and wave buoy (in red) used for the analysis (Vuik et al., 2012).

As a year, the period between two Jarkus measurements was considered. The storminess parameters were derived by using meteorological data derived from different stations and then interpolated at each Jarkus transect (Vuik et al., 2012). In particular, for the Wadden islands, the following stations have been used: “Den Helder” and “Huibertgat” for the water levels and “Eierlandse Gat” and “Schiermonnikoog Noord” for the wave data. The locations of the different stations can be found in Figure 6.1.

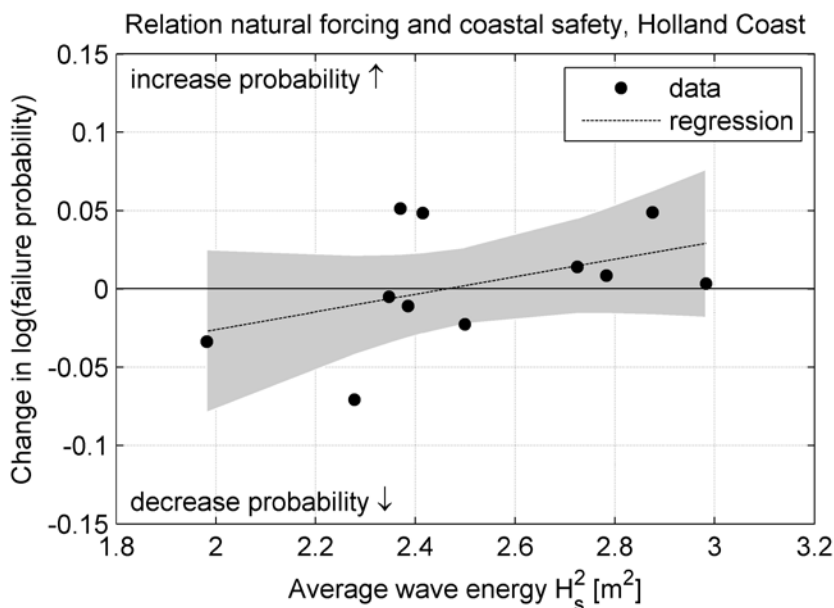
Figure 6.2 Changes in probability of breaching as a function of the yearly averaged wave energy for the Holland coast (Giardino et al., 2014a). The dashed line indicates the regression line between points, while the grey band the confidence interval around the regression.

According to Vuik et al. (2012), the most suitable storminess parameter to describe changes in short term safety is the yearly mean wave energy. In general terms, the higher the wave activity for a specific year, the higher is the expected increase in probability of breaching of the first dune row (Figure 6.2).

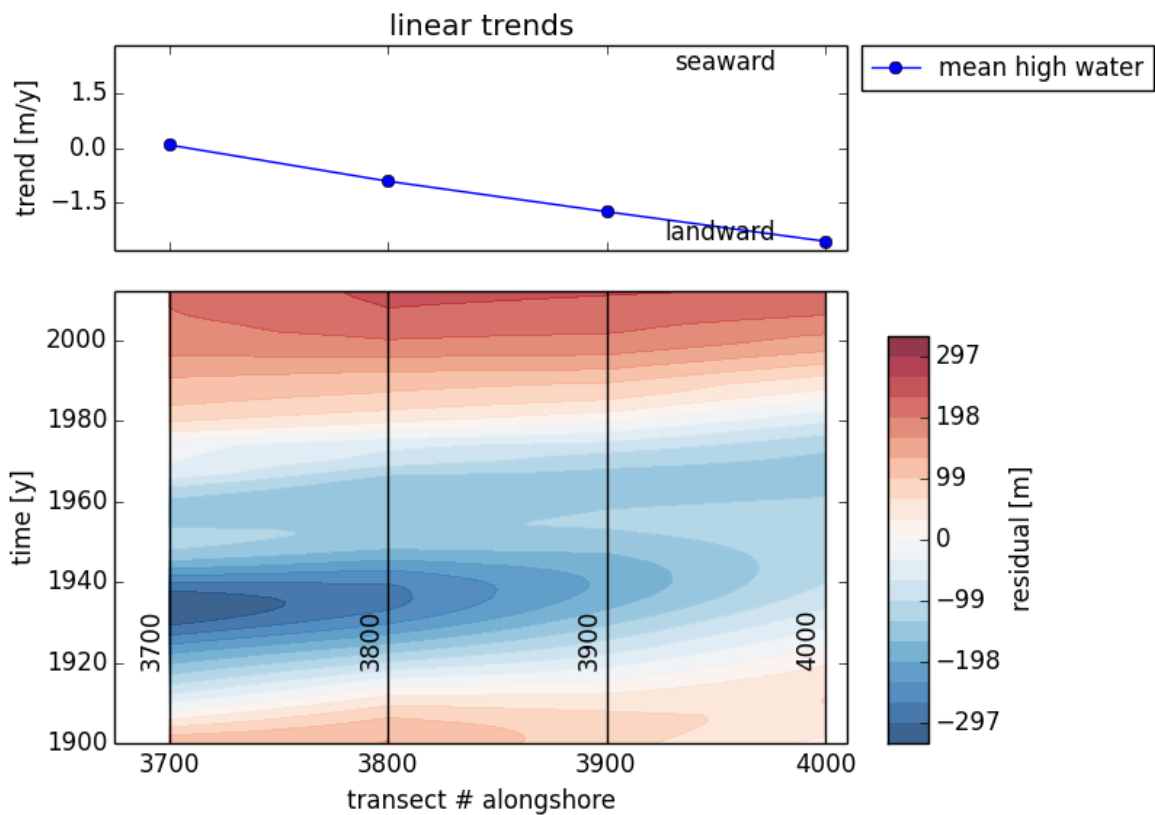
Figure 8.3 Linear trend of mean high water position (top) and contour plot of residual mean high water position (below) for a part of Vlieland. See Figure 8.2 for the location.

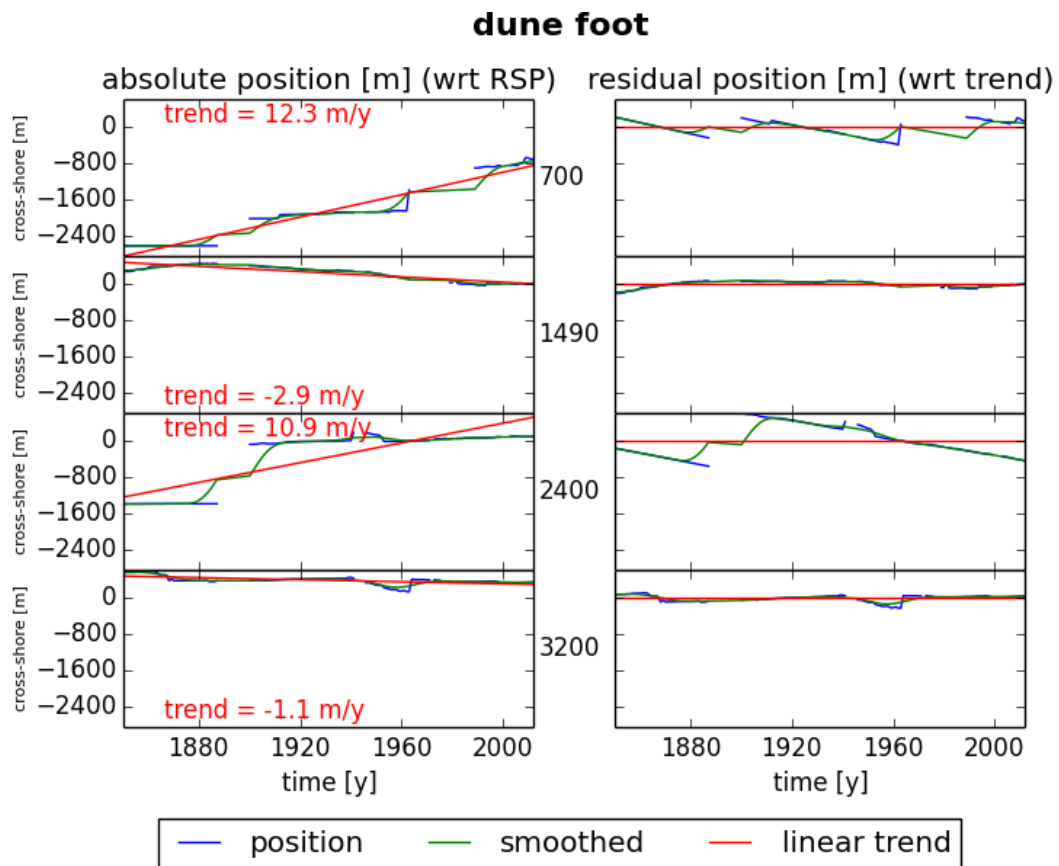
Figure 8.5 Dune foot position for four transects at Texel. The blue line represents the actual dune foot position changes, the green line the smoothed dune foot position after applying a low-pass filter, and the red line the linear trend. The figures in the left panel show the absolute values, while the figures in the right panel show the values relative to the linear trends.

Moreover, in the top panel of the same figure, a peak in the linear trend is found at transect 700. This is caused by morphological changes following a staircase pattern which is visible in Figure 8.5, where the changes in dune foot position are plotted for four different transects (transect 700, 1490, 2400, 3200). A similar staircase pattern is also found at transect 2400. Detailed inspection shows that the same behaviour occurs between transects 700 to 800 (near the south-western island tip) and between transects 2300 to 2700 (around the slufter). The reason for the jumps in the dune foot position is most likely related to the emergence of new dune rows. For example, the changes occurred around transect 700 approximately at year 1910 were related to the landing of the shoal Onrust (Figure 8.16). Therefore, this is not related to a typical sand wave feature although can influence the contour plot in Figure 8.4 (b).

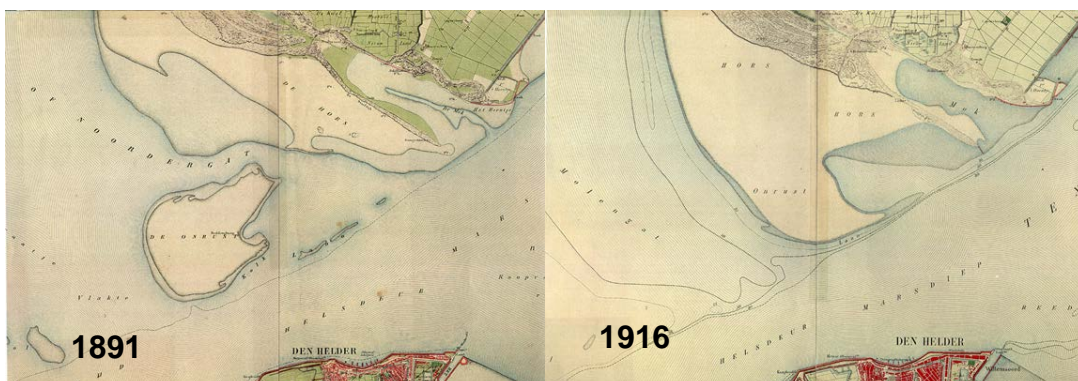
Figure 8.6 Historical maps of the southern tip of Texel. On the left hand side, map of the year 1891, on the right hand side map of the year 1916.

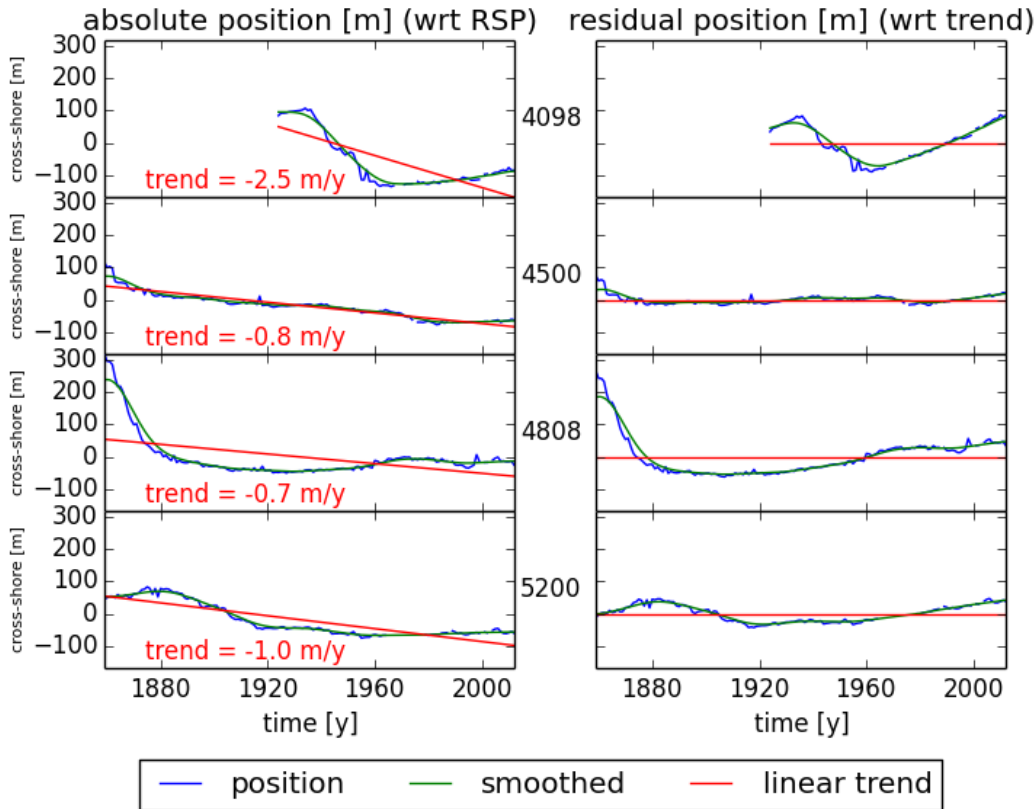
Figure 8.8 Dune foot position for four transects at Vlieland. The blue line represents the actual dune foot position changes, the green line the smoothed dune foot position after applying a low-pass filter, and the red line the linear trend. The figures in the left panel show the absolute values, while the figures in the right panel show the values relative to the linear trends.

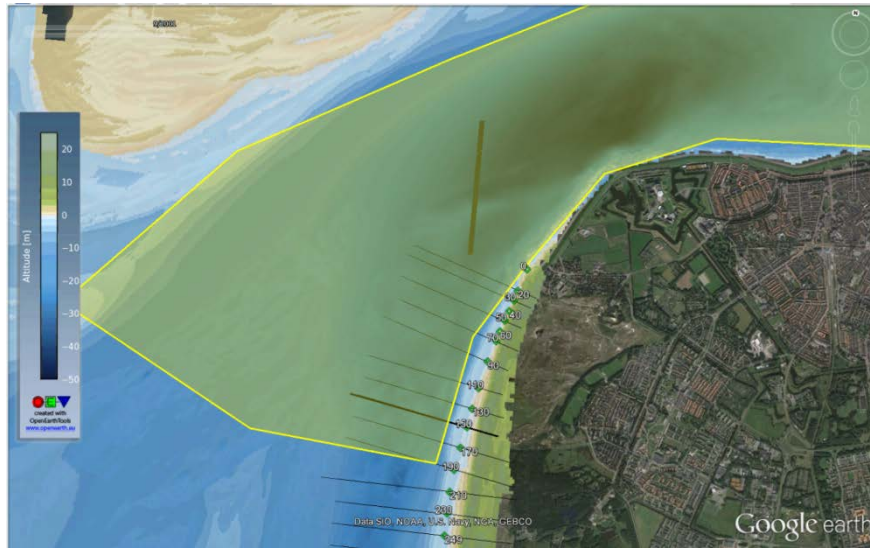
Figure 8.19 Detail of the Helsdeur. Coastal indicators for the highlighted transect (7000150) are investigated.

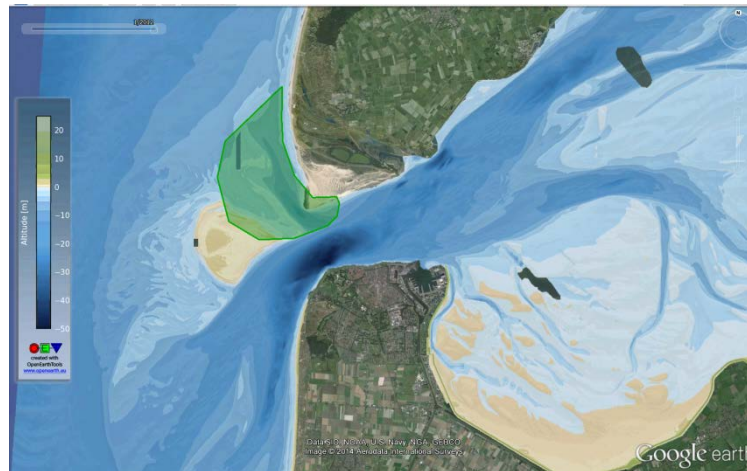
Figure 8.21 Limit of the region defining the Molengat.

Along Texel island, a smaller and shallower channel is located called the Molengat. This channel is located ~500 m off the coastline of Texel. A polygon defining the area around the Molengat is shown in Figure 8.21.

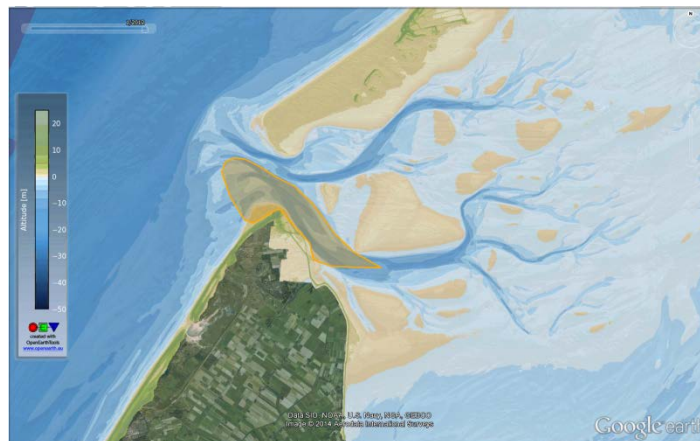
Figure 8.26 Limit of the region defining the Robbengat.

The Robbengat channel is situated in the Eierlandse Gat inlet, between Texel and Vlieland islands. This channel has a maximum depth of about 15 m. The polygon around the channel is shown in Figure 8.26. Bathymetries are available within the polygon for the period between 1970 and 2012.

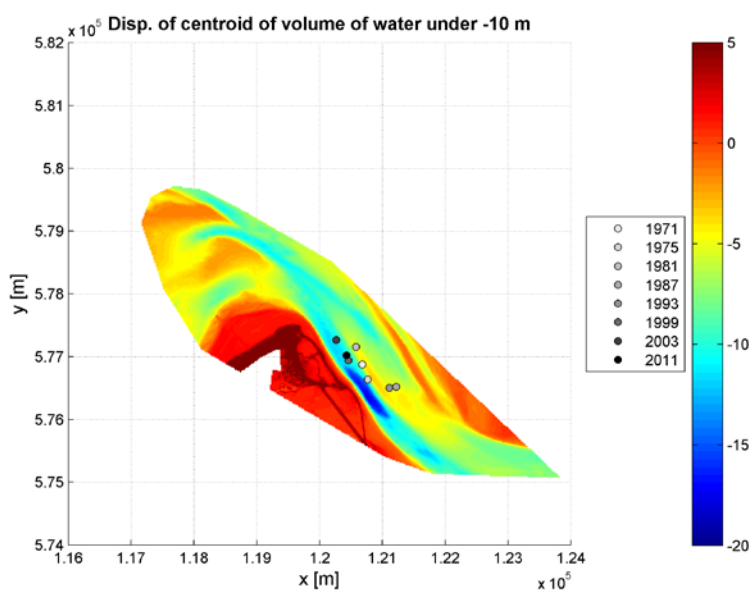
Figure 8.28 Displacement of the centre of mass of water defined by the -10 m contour line for the Robbengat channel.

Two cross-shore profiles at transects 6003081 and 6003200 obtained from vaklodigen data and Jarkus data are shown in Figure 8.30 and Figure 8.31. Figure 8.30 clearly shows the effects of the Eierlandse Dam with large accumulation of sand volumes in front of the coast after 1995. Figure 8.31, located in front of the channel, confirms the high dynamicity of the channel as also shown by the movement of the centroid in Figure 8.28.

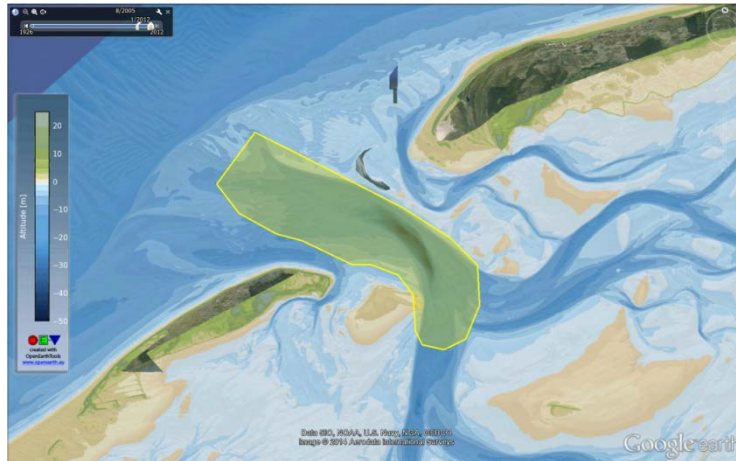
Figure 8.32 Limit of the region defining the Vliestroom.

The Vliestroom is the largest and deepest gully between Vlieland and Terschelling. The polygon used to define the area of the analysis is shown in Figure 8.32.

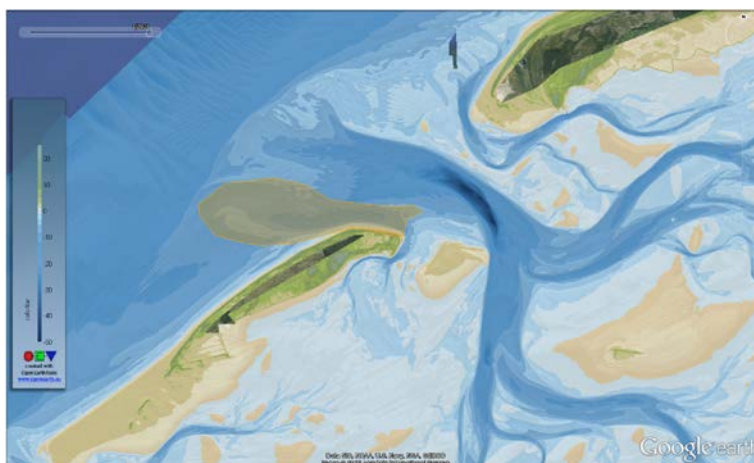
Figure 8.38 Limit of the region defining the Zuiderstortemelk.

The Zuiderstortemelk channel is located next to the Vliestroom, along the northern tip of Vlieland island. The polygon around the channel, used to define the area for the analysis, is shown in Figure 8.38.

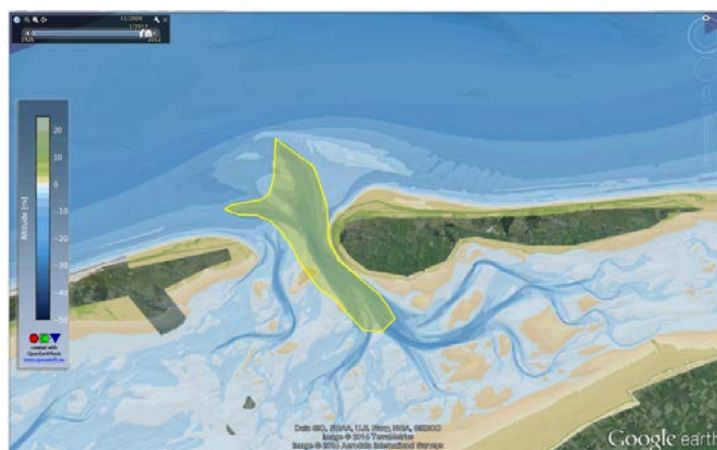
Figure 8.44 Limit of the region defining the Borndiep.

The Borndiep channel is the deepest channel of the Ameland inlet, between Terschelling and Ameland. The polygon around the channel used to define the area for the analysis is shown in Figure 8.44.

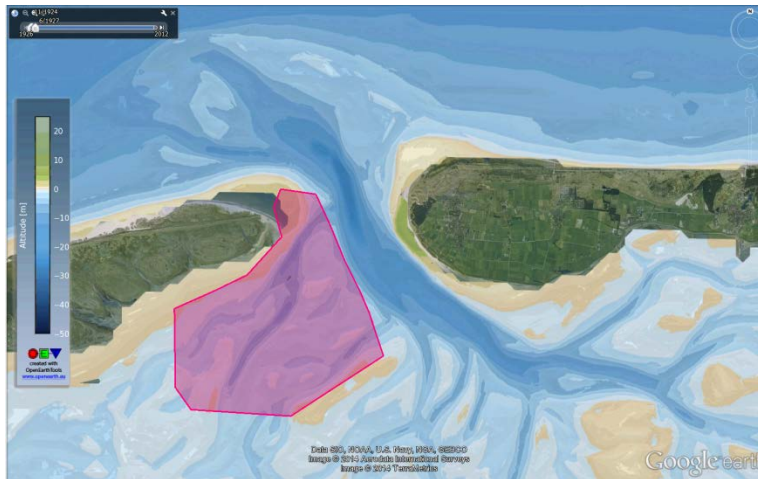
Figure 8.49 Limit of the region defining the Boschgat.

The other channel located in the Ameland inlet is the Boschgat. Also this channel is very dynamic and influenced by the periodic changes which have occurred within the entire inlet. The polygon around the channel is shown in Figure 8.49. Since the channel is very dynamic

in time, the polygon around this channel is very wide so that can follow the time development of the channel system.

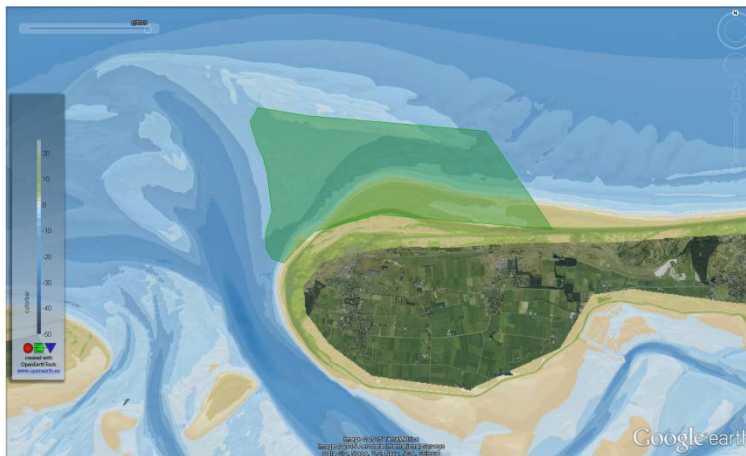
Figure 8.53 Limit of the region defining the Oostgat.

The channel has a maximum depth of about 7 m. The polygon around the area with the channel is shown in Figure 8.53. Bathymetry data is available within the polygon for the period between 1926 and 2011. Figure 8.54 shows the volume development in time of the deeper part of this channel system. As this channel is shallower than the others investigated in this report, volumes are computed between the sea bed and the -5 m water level (instead of -10 m as for the other channels). Volume changes in the last 40 years are in general quite limited. More important are the periodic shifts in time of this channel, and which have a direct consequence on the development of the coastline indicators. Figure 8.55 shows the development in time of the centre of mass, for the area defined by the -5 m contour line. The figure clearly indicates the progressive shift of the channel towards the south-east approximately during the last 20 years and with a speed of about 150 m/year.
