Impact ditch on dike stability during uplift

Factual report centrifuge tests

Client	SITO Moonshot 2
Contact	Ap van Dongeren
Reference	-
Keywords	Dike stability, uplift, centrifuge testing

Version	1.1
Date	23-01-2025
Project nr.	11210298-020
Document ID	11210298-020-GEO-0002
Pages	82
Classification	Public
Status	Final

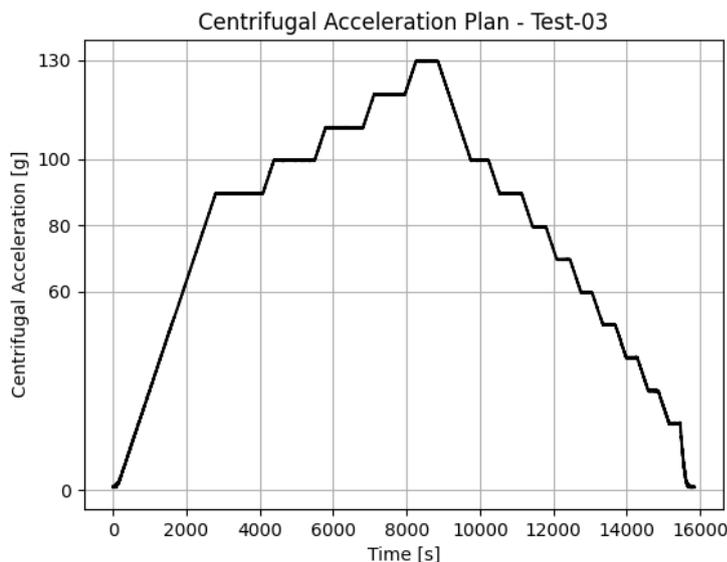
Figure 3.1 Centrifugal acceleration plan of calibration Test 03.

A calibration test was conducted to test the cameras and the pore water pressure transducers. The test ran with an empty strongbox except for water and a checkerboard for the cameras. The applied g-level went stepwise up to 130 g and down again. The centrifugal acceleration plan is shown in Figure 3.1 below. The target pressure for the PPTs can be calculated from the water level, which was at 170 mm throughout most of the test based on camera footage, taking into account the position of the sensor within the strongbox. These positions are shown in Figure 2.1 and the vertical distances are presented in Table 3.1. For PPT 7-11, the measured pore water pressures and calculated value per g-level is shown in **Error! Reference source not found.** below. To calibrate the sensors, a fitting factor is calculated for each sensor. This is based on the ratio between the calculated value at a certain g-level and the measured value at that g-level for each sensor. The fitting factors (shown in Table 3.2) are then applied to the sensor measurements, as shown in **Error! Reference source not found.** As the data from PPT 11 deviates much from the other sensors and is not stable at g-levels, it is advised to be careful in the interpretation of PPT 11. The same was done for PPT 5 and 6, standpipes and for the total pressure transducers. These are found in **Error! Reference source not found.** to **Error! Reference source not found.**

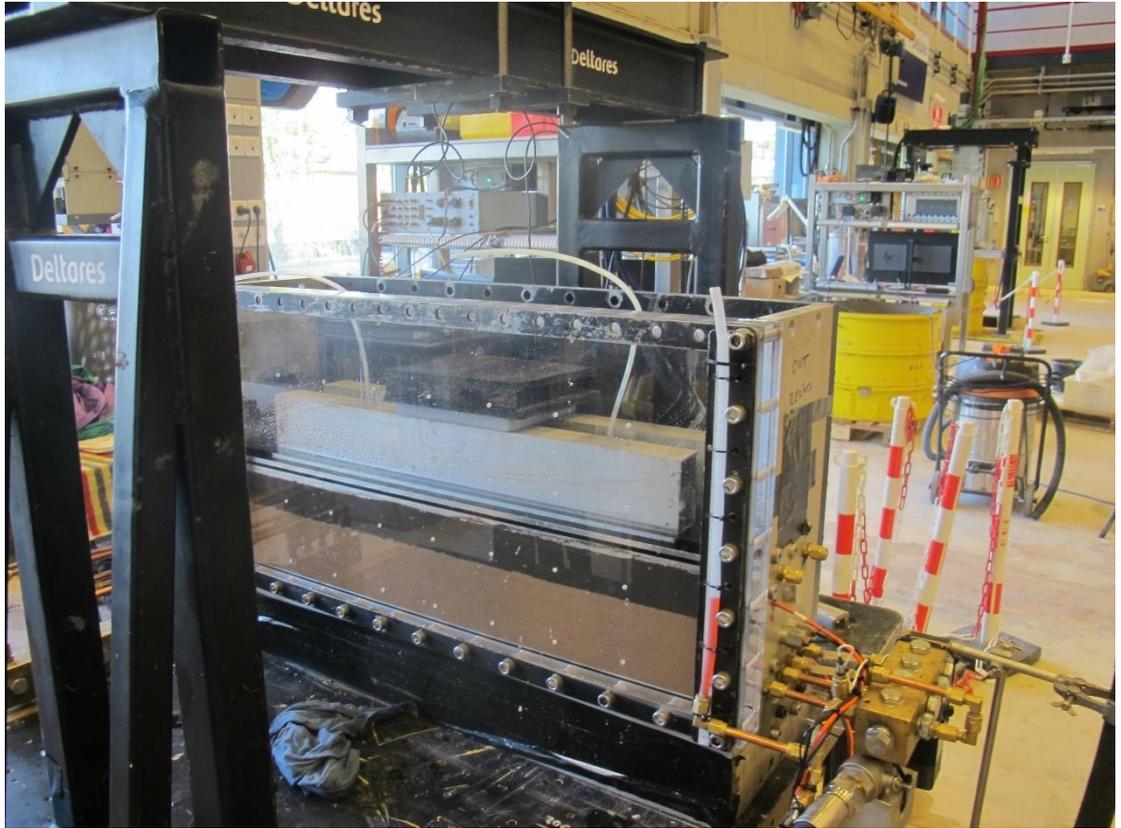
Figure 5.1 Set-up of the consolidation process of the clay cover, prior to testing in the strongbox.

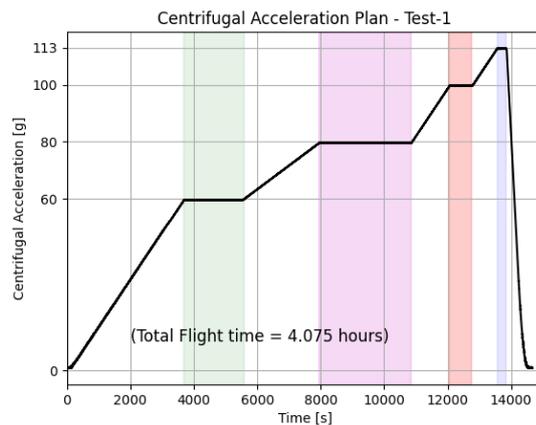
Figure 5.4 Centrifugal acceleration plan of Test 1.

The hydraulic head in the sand layer was raised by stepwise raising the plunger. The insured 33 kPa increase water pressure was reached. A lift of 22 mm of the plunger resulted a 15 kPa increase. Therefore, for each mm of lifting there is a 0.69 kPa increase in water pressure so the plunger was lifted by 57 mm to reach an increment of 33 kPa in water pressure. It should be noted that in test 10 a lift of 85 mm was needed to reach the same pressure increment. An additional lift of 10 mm was applied, bringing the total to 67 mm, to assure a visible uplift of the cover layer. Then, the g-level was increased towards the level of 91 which was the g-level at failure for test 10, but no failure occurred in this test until the g-level was further increased to 113. Figures 5.8 to 5.13 show data from the sensors in the strongbox. The PPTs and TPs are calibrated according to the methods laid out in **Error! Reference source not found. Error! Reference source not found.** The DCDTs were corrected (nulled) based on their respective starting value at t=0.

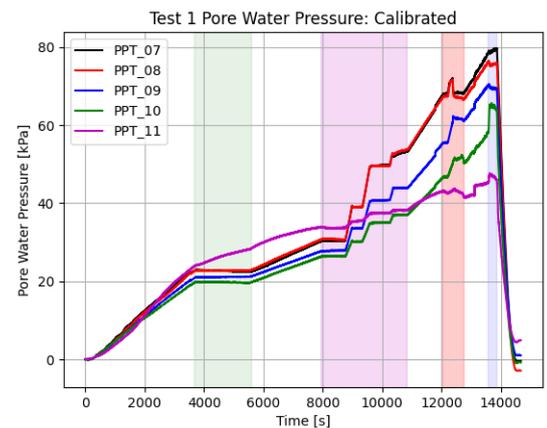
Figure 5.5 Pore water pressures at locations P7-P11 calibrated.

Pore water pressure values are similar to what was observed in reference test 10, but do suggest that the water on top of the clay cover layer and water in the sand were connected, already from the start of the test, since the PWP levels represent a water height that is higher than expected if only the water height in the sand was measured and coincide with the water height on top of the clay.

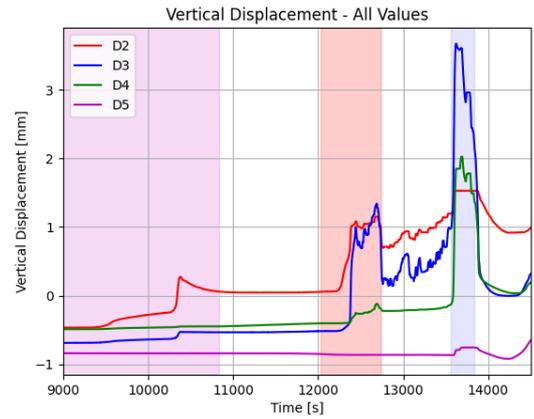
Figure 5.11 Vertical displacement during uplift and failure.

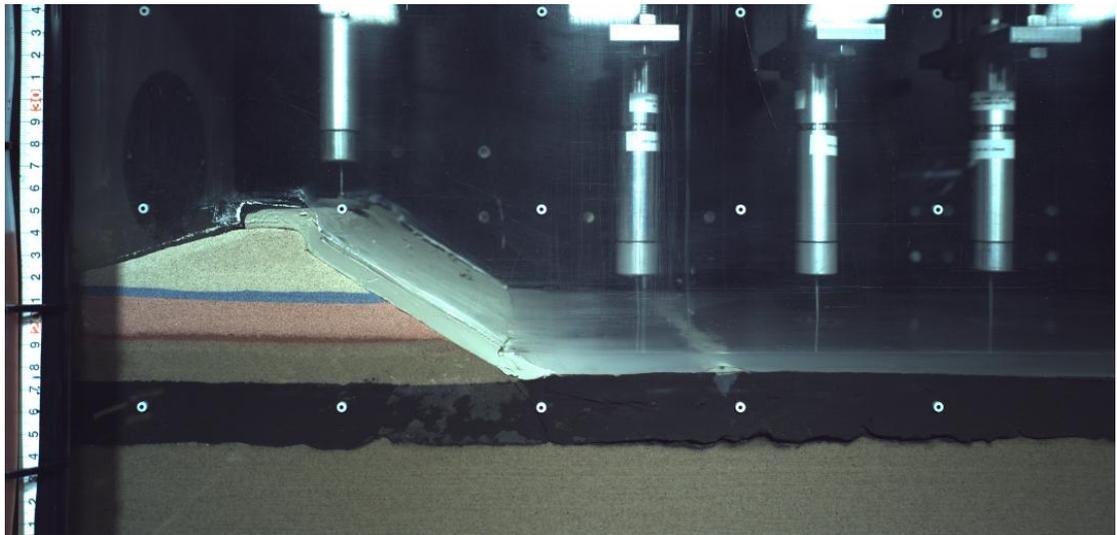
Figure 5.12 Maximum uplift of the clay cover layer.

Uplift was initiated at a g-level of 80, when the hydraulic head was 21.1 cm according to the standpipe visible on camera footage, and 20 cm according to PPT 5 as shown in **Error! Reference source not found.** below. Uplift was most present at D2 and D3 as shown in **Error! Reference source not found.**, but reached a maximum length of 27.73 cm at a g-level of 100.

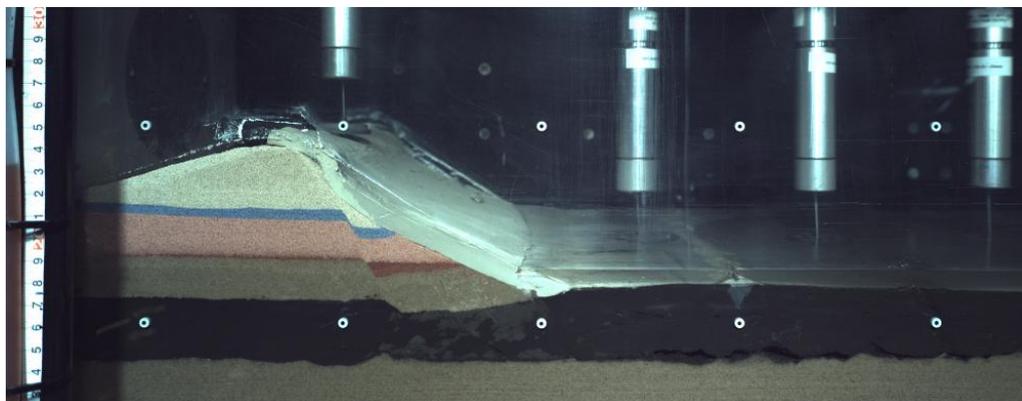
Failure occurred at a g-level of 113. As seen in Figure 5.13, there is a large sliding plane and a smaller one on its right side. The clay cover layer is lifted up between D2 and D3, but no cracking of the layer occurred due to lateral pressure of the failing dike body.

Figure 5.13 Failure of the dike body during the experiment.

The two sliding planes identified in Figure 5.13 are also recognised in the clay layer after excavation of the dike as seen in Figure 5.14 below. Sand boils appeared at the diagonal crack at the toe and at 40 cm from the left side of the strongbox (**Error! Reference source not found.** and **Error! Reference source not found.**). Full excavation of the clay layer shows sand erosion under the clay (see Figure 5.17), including erosion around the toe and at 40 cm, where the other sand boil was found.

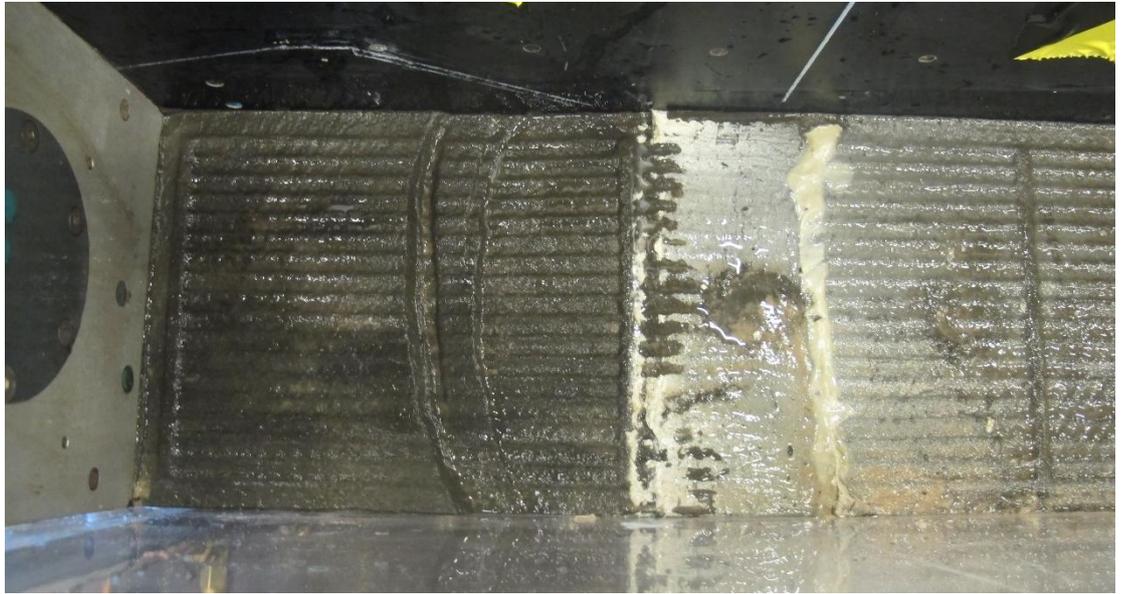
Figure 5.14 Sliding planes visible in the clay after removing the sand dike body.

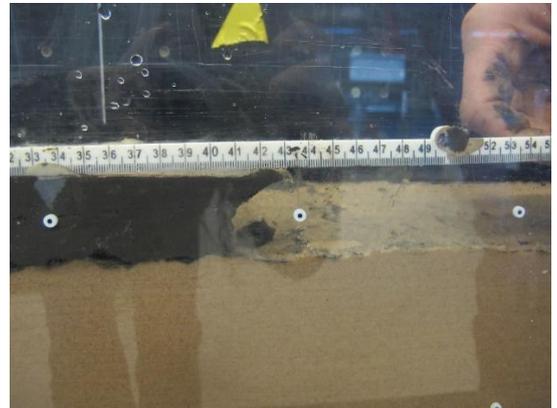
Figure 5.16 Close-up picture of the excavated sand boil at 40 cm from the left side of the strongbox.

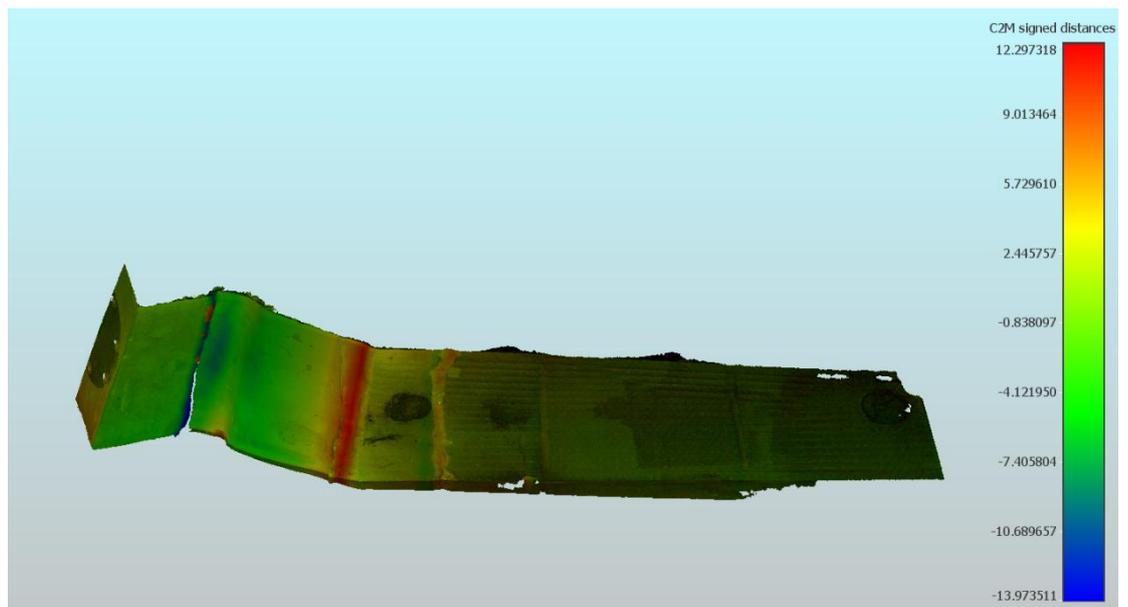
The dike model was laser scanned before and after the experiment. In Figure 5.18, the model after the experiment is shown, with a colour projection showing the displacement compared to the laser scan before the test. Blue shows sinking (at the crest) and red shows upward displacement (at the toe).

Figure 5.18 Laser scan of dike body with clay layer after failure of the dike. Distance computed [mm] in reference to the dike before failure. Blue shows sinking (at the crest) and red shows upward displacement (at the toe).

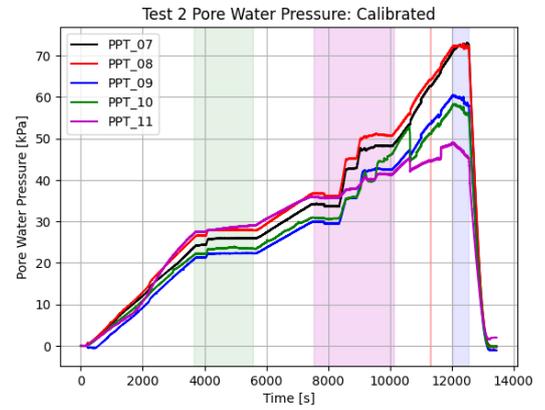
Figure 6.4 Pore water pressures at locations P7-P11 calibrated.

PPT10 shows a drop in pressure around the peak of the vertical displacement in D3 and D4, at about 10500 seconds in the experiment. At the location of PPT10, a sand boil was found after the experiment which could explain the sudden drop in pressure.

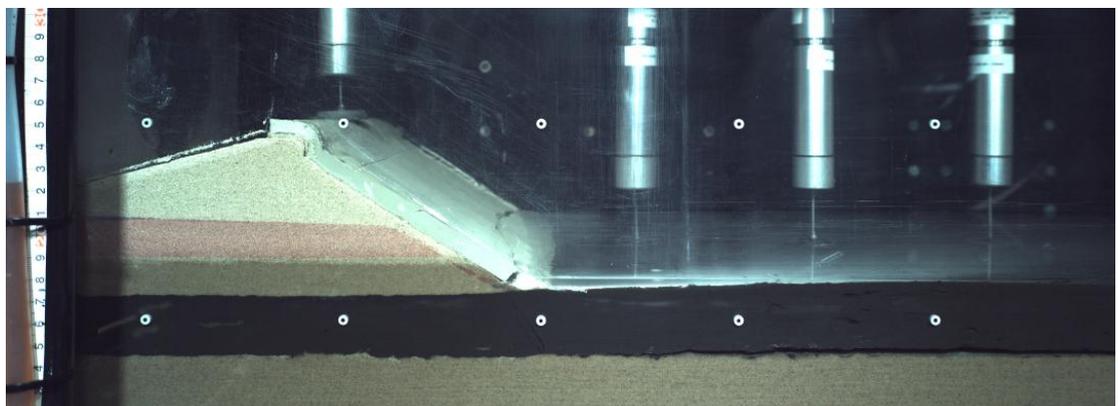
Figure 6.11 Maximum uplift of the clay cover layer.

As shown in Table 6.1, the first signs of uplift are already visible after increasing the hydraulic head for the first time, see **Error! Reference source not found.** Maximum uplift length is reached after the third hydraulic head increased, still at 80g. The uplift length is longer than found in Test 1 and as seen in **Error! Reference source not found.**, sensor D4 shows significant uplift.

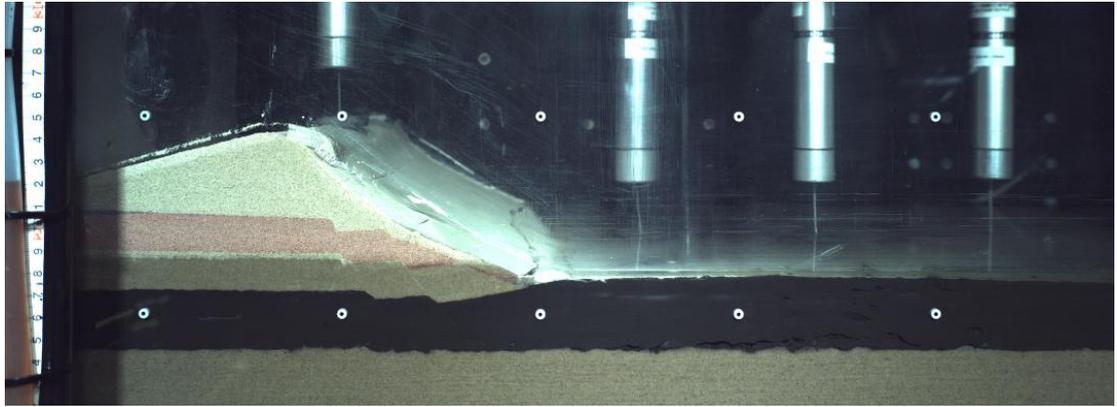
Failure occurred at 112 g. Two sliding planes are visible in the side camera footage as shown in Figure 6.12. The diagonal crack at the toe that was still visible in Figure 6.11 has been closed after failure and the cover layer is lifted up around D3. No cracking of the cover layer at the surface is seen.

Figure 6.12 Failure of the dike body during the experiment.

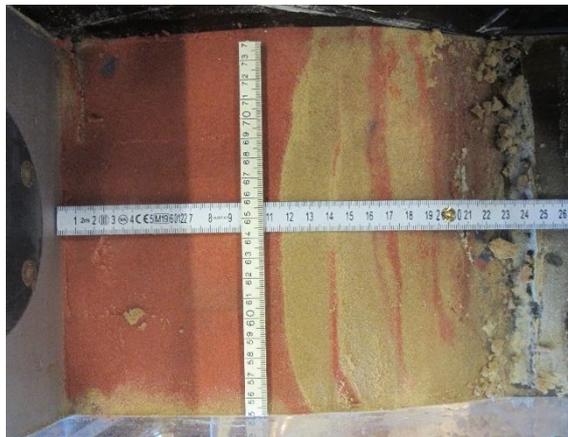
Error! Reference source not found. and **Error! Reference source not found.** show multiple sliding planes in a similar shape as seen in test 1. Several sand boils were found, mostly along the back wall, and the clay layer had many lateral cracks.

Figure 6.13 Sliding planes visible in the coloured sand layers after partial excavation of the dike.

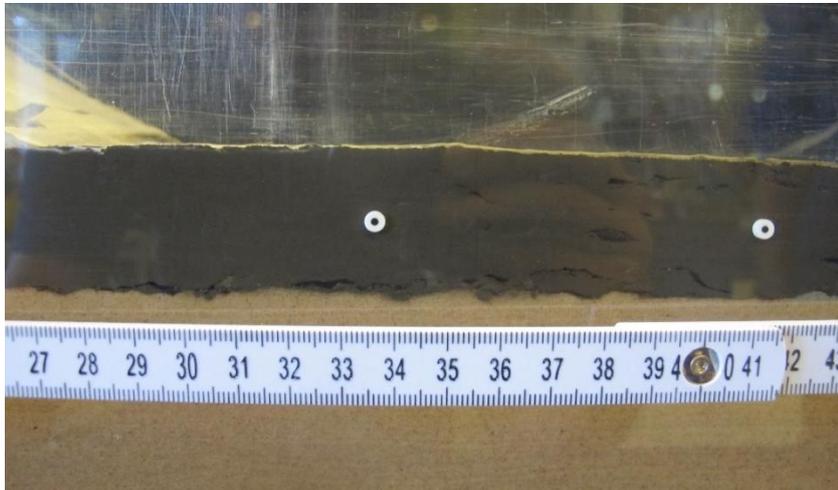
Figure 6.17 Lateral cracks in the clay cover layer.

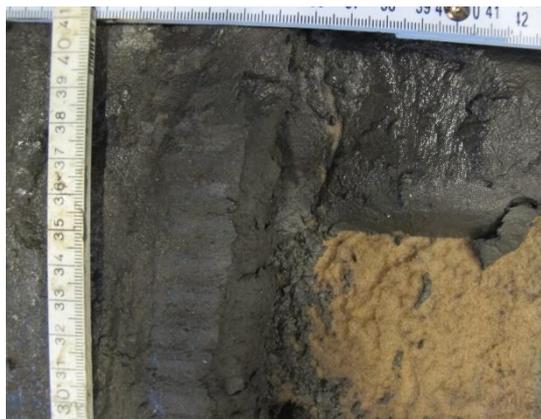
Figure 6.18 Sand boil at 37 cm from left side of the strongbox, seen after partial excavation of the clay layer. Lateral crack visible at top of the picture

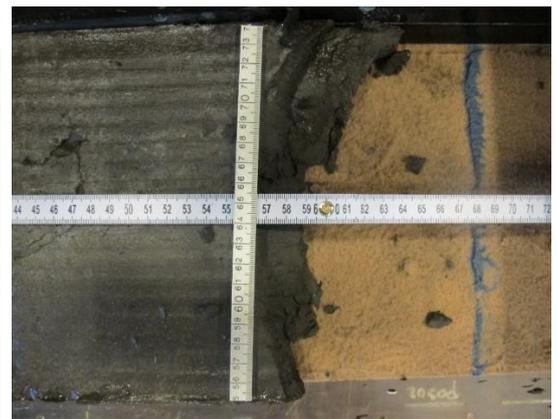
Figure 6.19 Sand erosion visible in the sand under the clay layer, especially along the back wall.

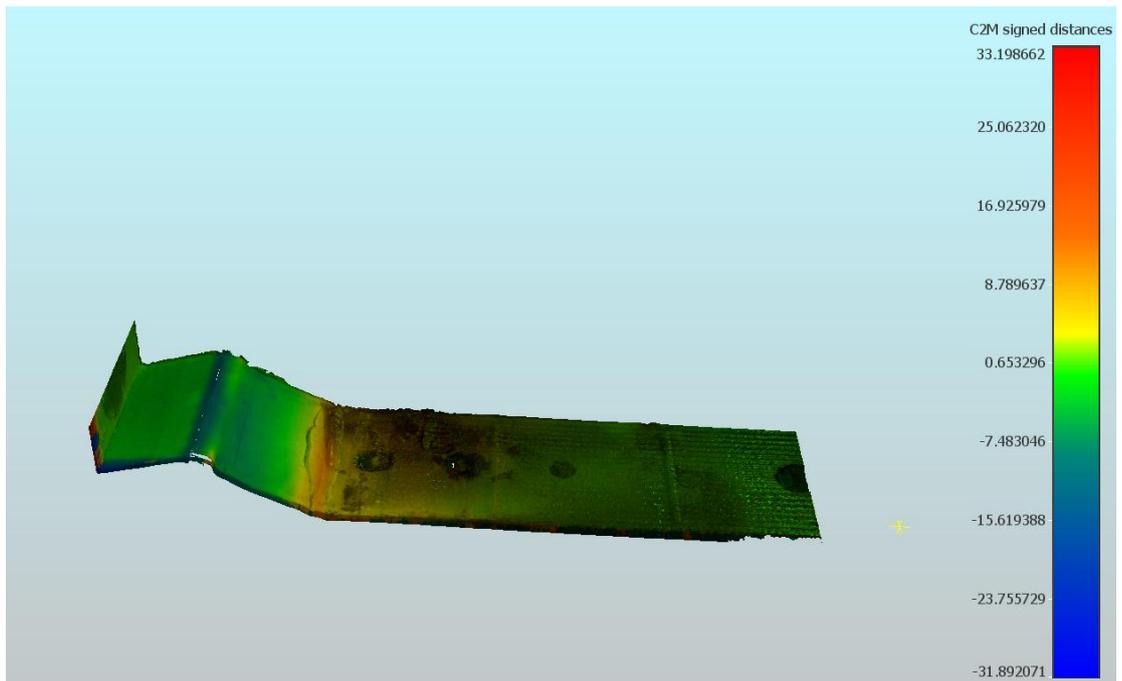
Comparing laser scans from before and after the experiment show similar results as found in Test 1. At the crest there is negative displacement, settlement, and at the toe there is positive displacement.

Figure 6.20 Laser scan of dike body with clay layer after failure of the dike. Distance [mm] computed in reference to the dike before failure. Blue shows sinking (at the crest) and red shows upward displacement (at the toe).

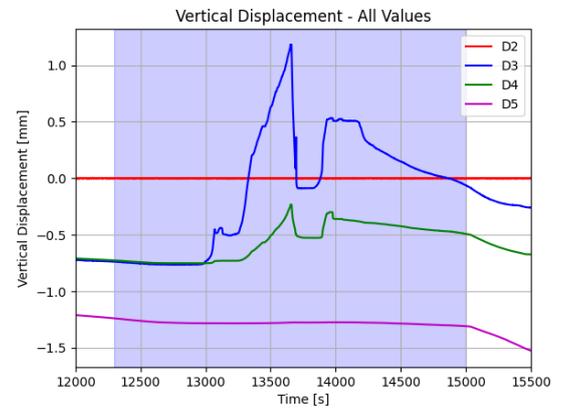
Figure 7.7 Vertical displacement during uplift and failure.

Table 7.1 shows that the maximum uplift length was 39.18 cm, which is similar to test 2. Figure 7.7 shows that uplift is found at D3 and D4, which supports the long uplift length derived from photo analysis. After initial uplift occurred, a sand boil formed from the crack at the toe and the toe of the dike started eroding more rapidly.

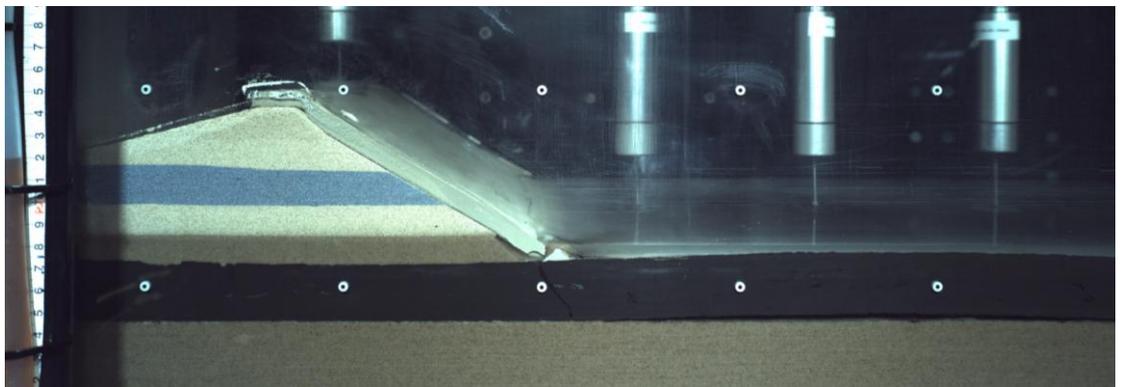
Figure 7.8 Maximum uplift of the clay cover layer.

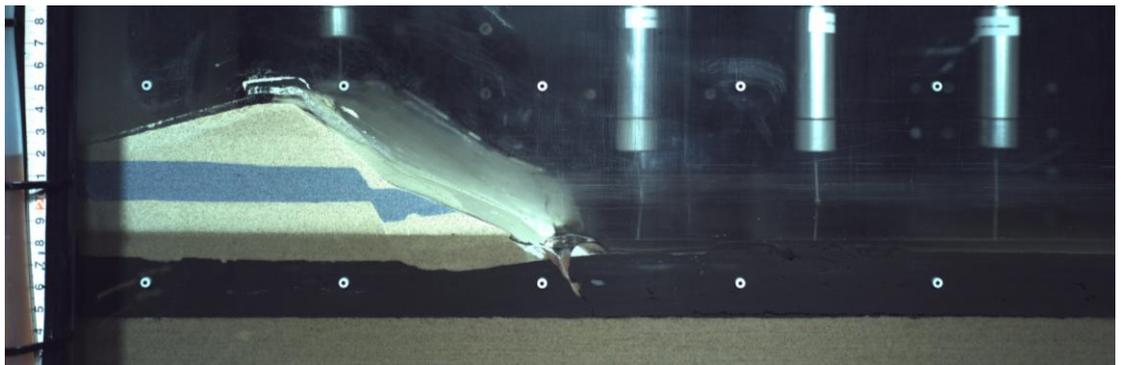
Figure 7.9 shows two sliding planes and an eroded toe. The deformation of the dike body did not move the clay layer enough to fully close the crack at the toe. Around D3, the cover layer is lifted up but no cracks formed at the surface.

Figure 7.9 Failure of the dike body during the experiment.

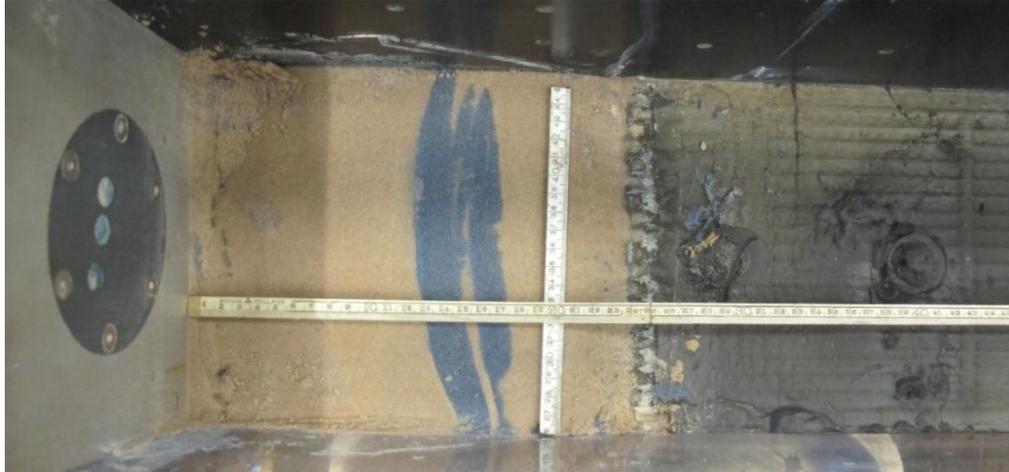
Partial excavation of the sand dike body shows two sliding planes in **Error! Reference source not found.**. Some sand boils are also visible along the glass front wall and around 40 cm. Lateral cracks and lamination are shown in *Figure 7.11*. *Figure 7.12* shows sand erosion between 27 and 47 cm from the left side wall. In *Figure 7.13* some more erosion in the sand is shown along the glass front wall.

Figure 7.10 Sliding planes visible in the partially excavated coloured sand layer. Sand boils visible at 40 cm and along the glass side wall.

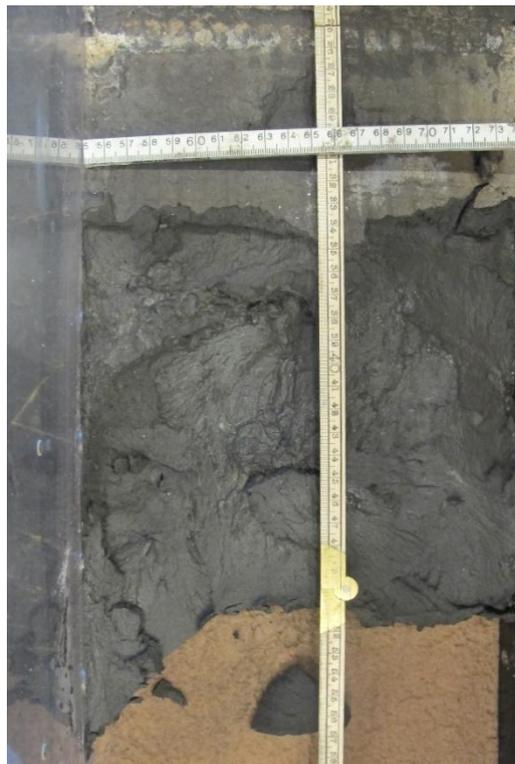
Figure 7.11 Lateral cracks in the clay layer.

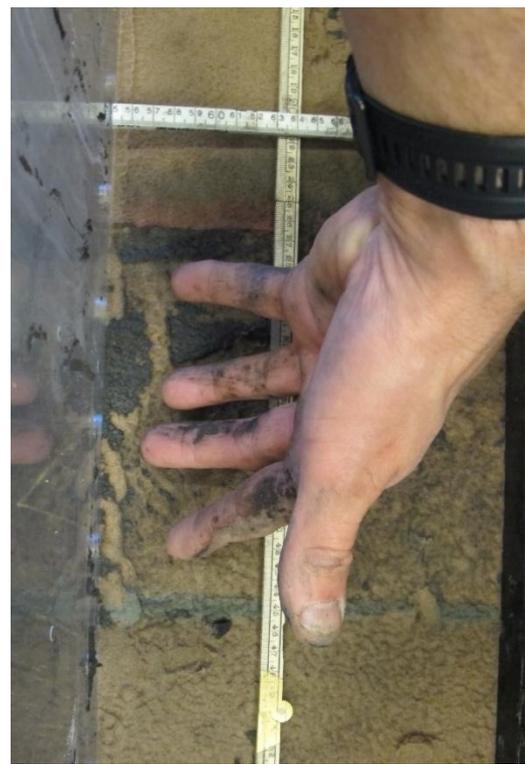
Figure 7.12 Sand erosion between 27 cm and 47 cm from the left side.

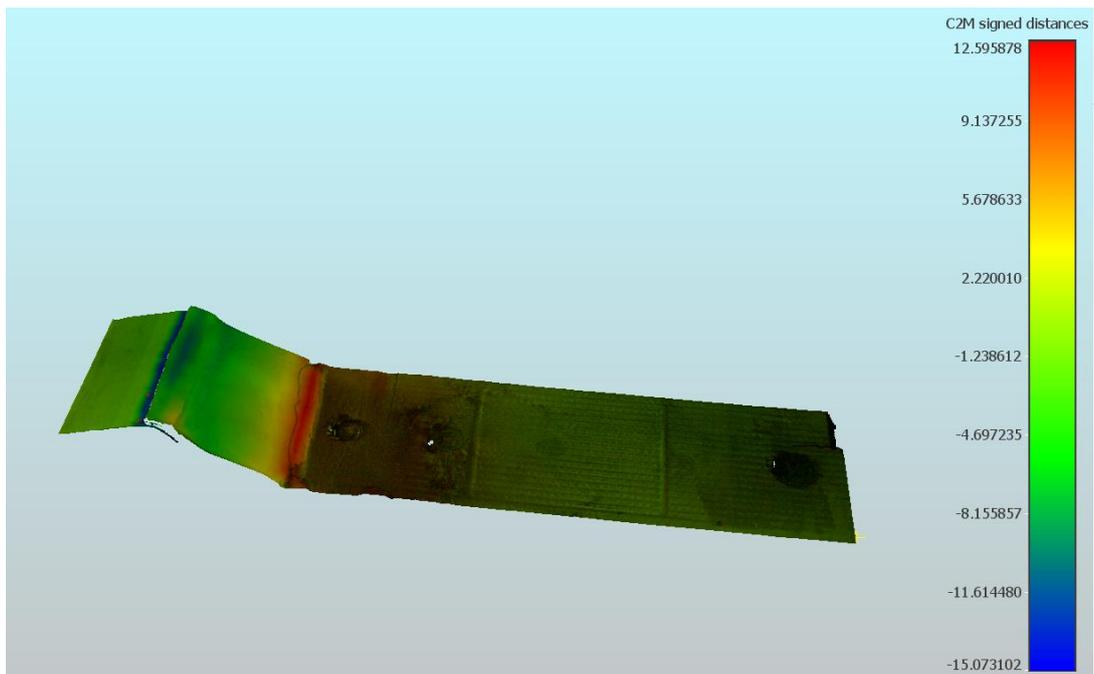
This laser scan analysis shows some more negative vertical displacement, settlement, at the inner crest of the levee and in at the centre. This is in line with the shape of the sliding planes, which is curved. There is a second band of red for positive vertical displacement after the toe, which is supported by the findings in the LVDT sensor data.

Figure 7.14 Laser scan of dike body with clay layer after failure of the dike. Distance [mm] computed in reference to the dike before failure. Blue shows settlement at the crest and red shows upward displacement at the toe.

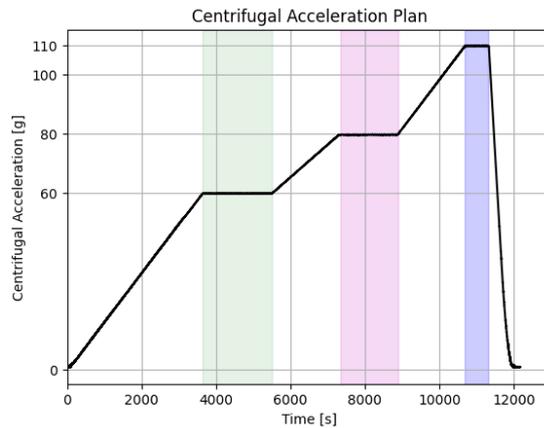
Figure 8.1 Centrifugal acceleration plan of Test 4.

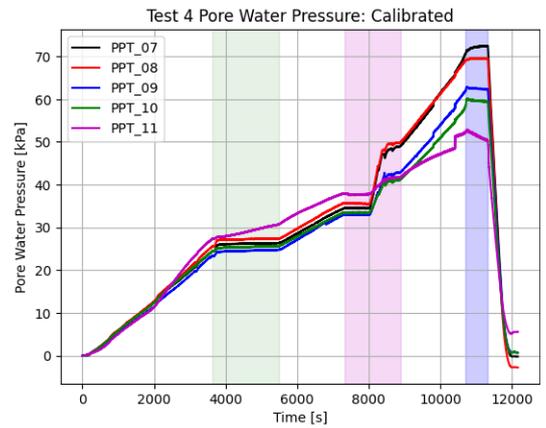
Figure 8.2 Pore water pressures at locations P7-P11 calibrated.

Pore water pressure and total pressure look very similar to what was seen in the previous 3 tests. The incorporation of the ditch is mainly reflected in sensor data from the DCDTs, *Figure 8.3*. Failure occurred at 110 g, which is very similar to test 1 and 2, which could mean that a small ditch near the toe of the levee does not influence the stability of the dike body significantly.

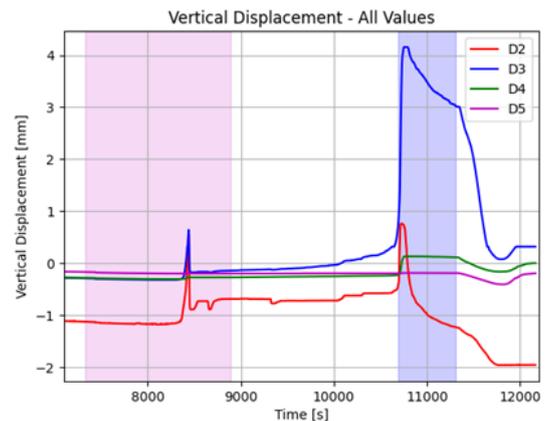
Figure 8.8 Vertical displacement during uplift and failure

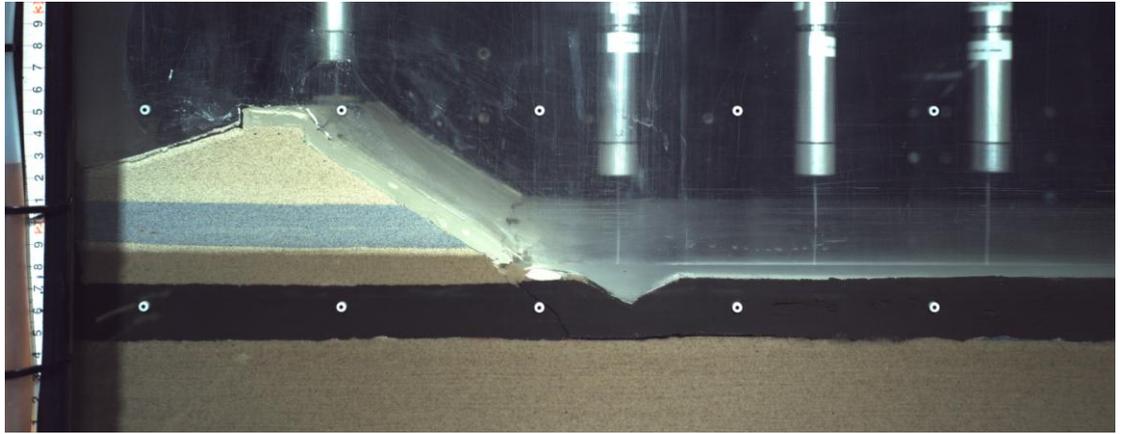
Figure 8.9 Maximum uplift of the clay cover layer.

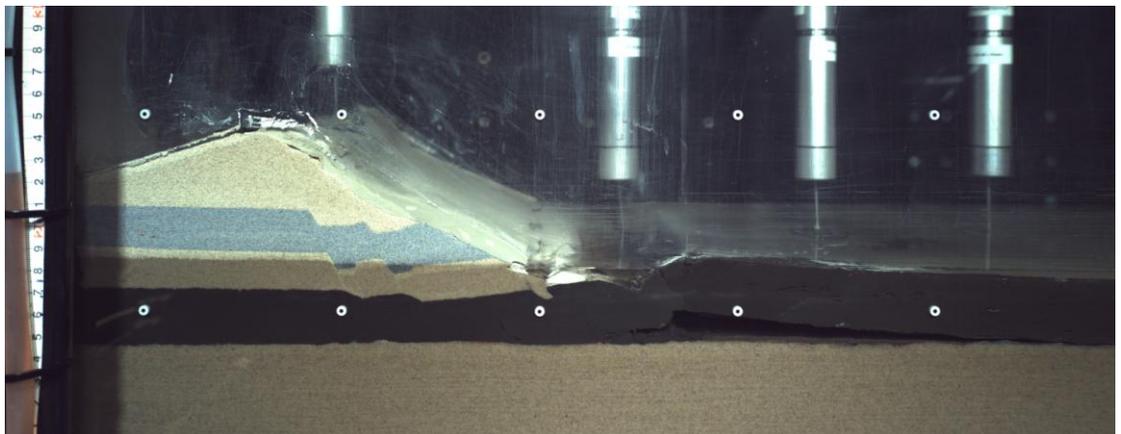
The dike body failed at 110 g, in multiple clearly recognisable sliding planes. The failure of the dike body drove lateral movement in the clay layer and caused the right side of the ditch to lift up significantly, and form a crack at the surface. The diagonal cracks at the toe were almost completely closed. Besides the deformations near the ditch, differences in the failure modes found in test 1, 2 and 3 seem to be small.

Figure 8.10 Failure of the dike body during the experiment.

The largest vertical displacement is found at D3, which is located on the right side of the ditch. When looking at Figure 8.10, even more vertical displacement would have been found closer to the ditch on the right side.

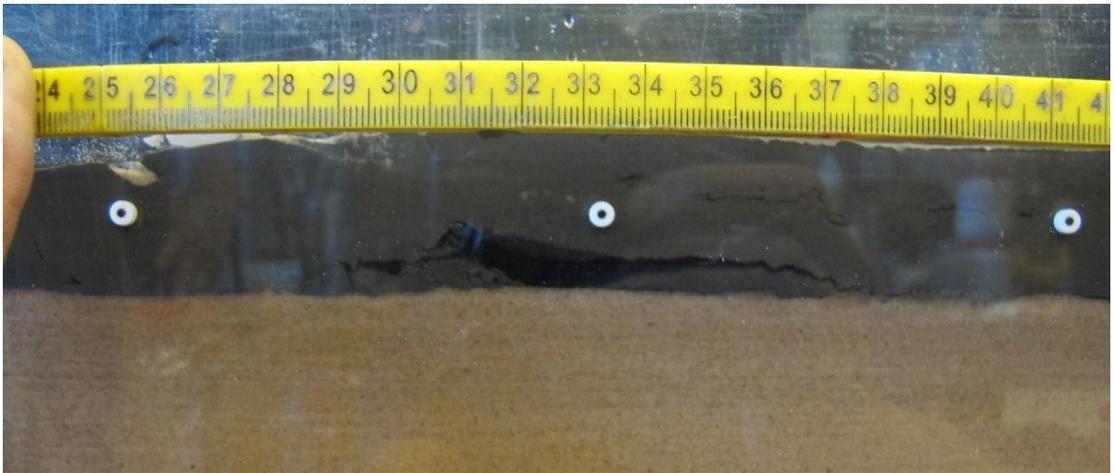
Figure 8.17 Lifted ditch bottom after dike failure.

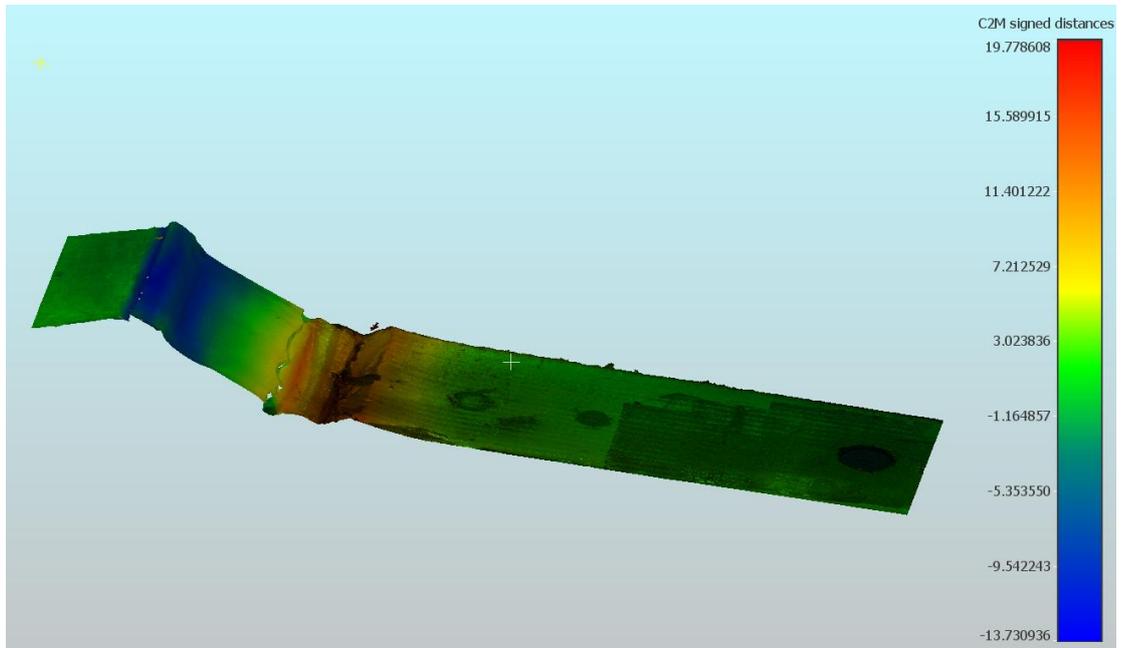
Figure 8.18 shows the difference in elevation by the laser scans prior and after the test.

Figure 8.18 Laser scan of dike body with clay layer after failure of the dike. Distance [mm] computed in reference to the dike before failure. Blue shows settlement (at the crest) and red shows upward displacement (at the toe).

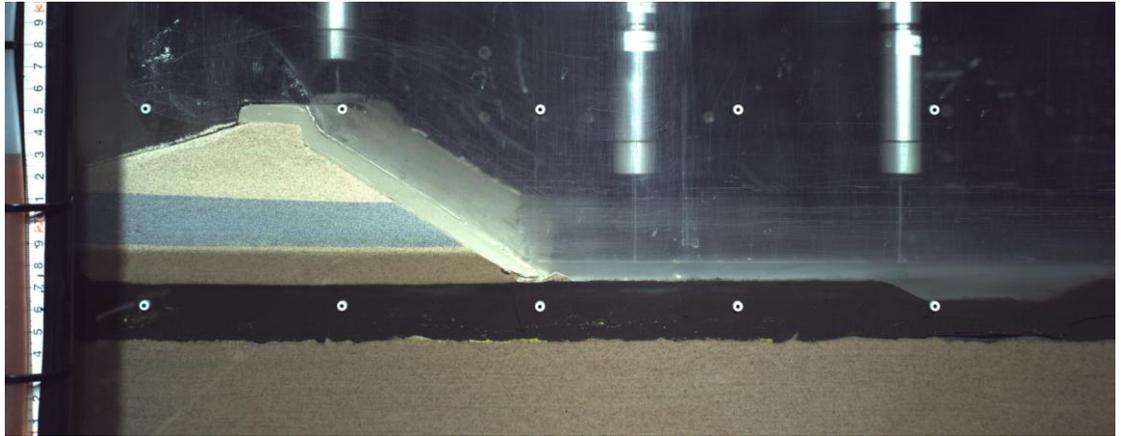
Figure 9.9 Maximum uplift of the clay cover layer.

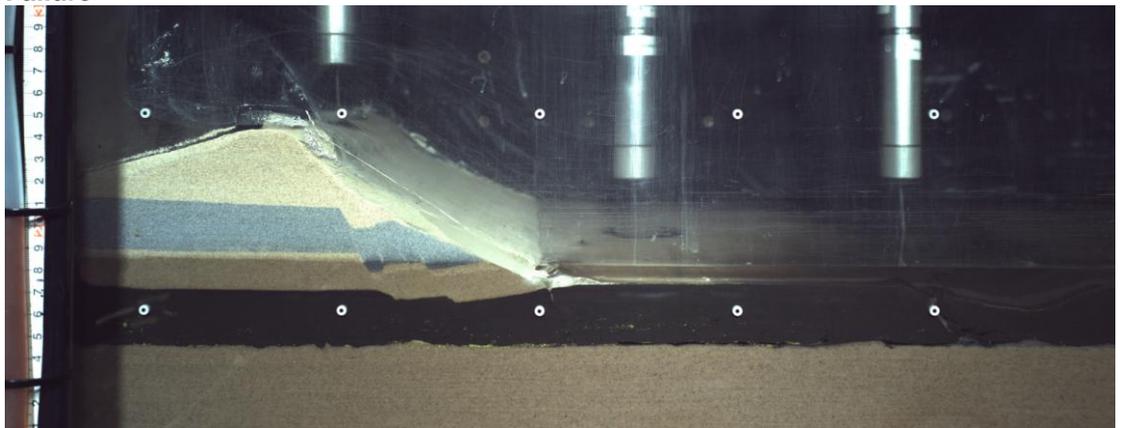
Figure 9.10 Failure of the dike body during the experiment.

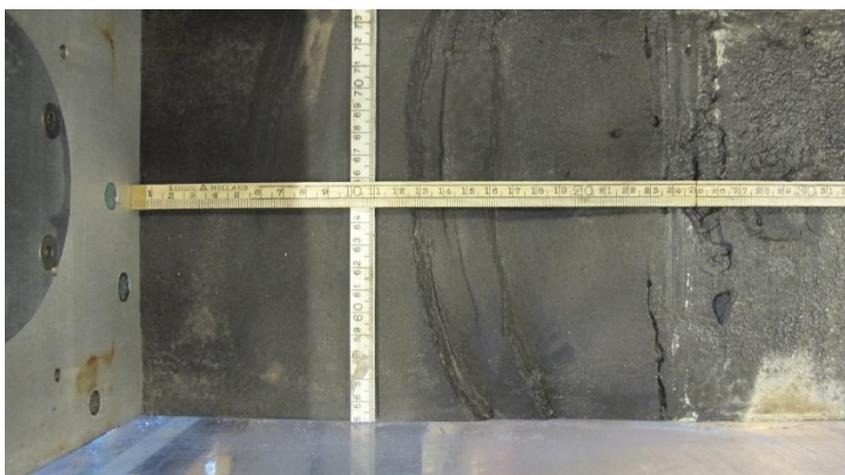
Post-test excavation of the model show multiple sliding planes, Figure 9.11 and Figure 9.12 in a similar shape as found in the previous tests in this series. A sand-boil at the ditch, Figure 9.13 and Figure 9.14, was found, as well as sand erosion under the clay layer, Figure 9.15 and Figure 9.16.

Figure 9.11 Sliding planes in the clay layer.

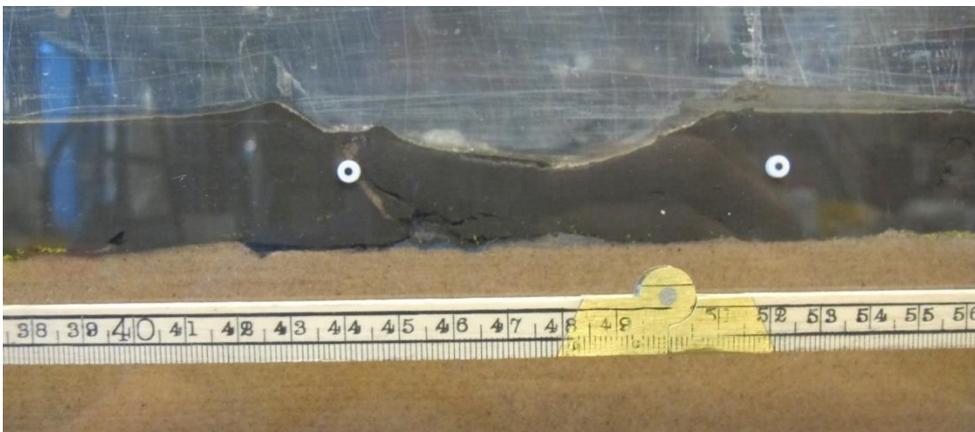
Figure 9.13 Side view of the ditch after failure, clearly showing a large crack and sand boil on the left side.

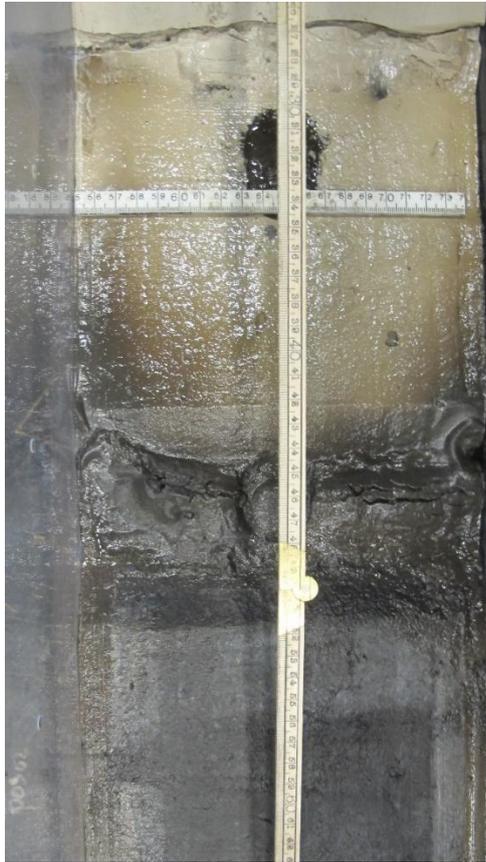
Figure 9.14 Top view of the ditch after failure. Sand boils visible along the width of the ditch (at about 46 cm).

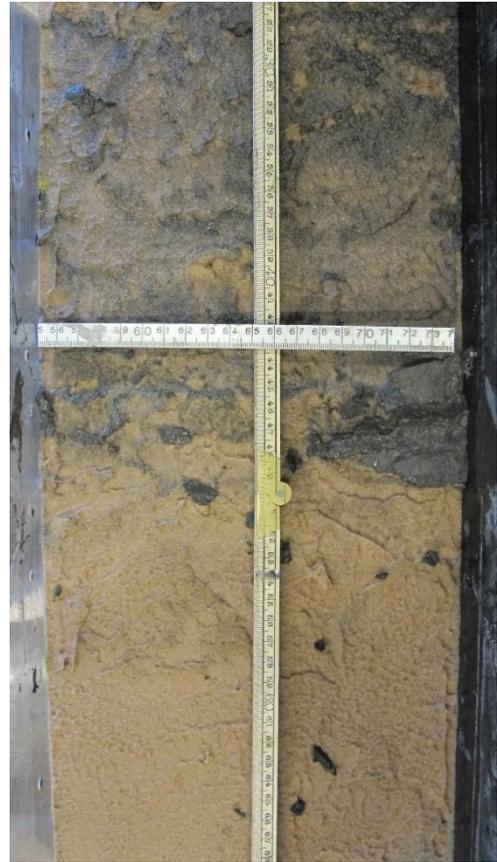
Figure 9.15 Sand erosion under the clay layer at the ditch location.

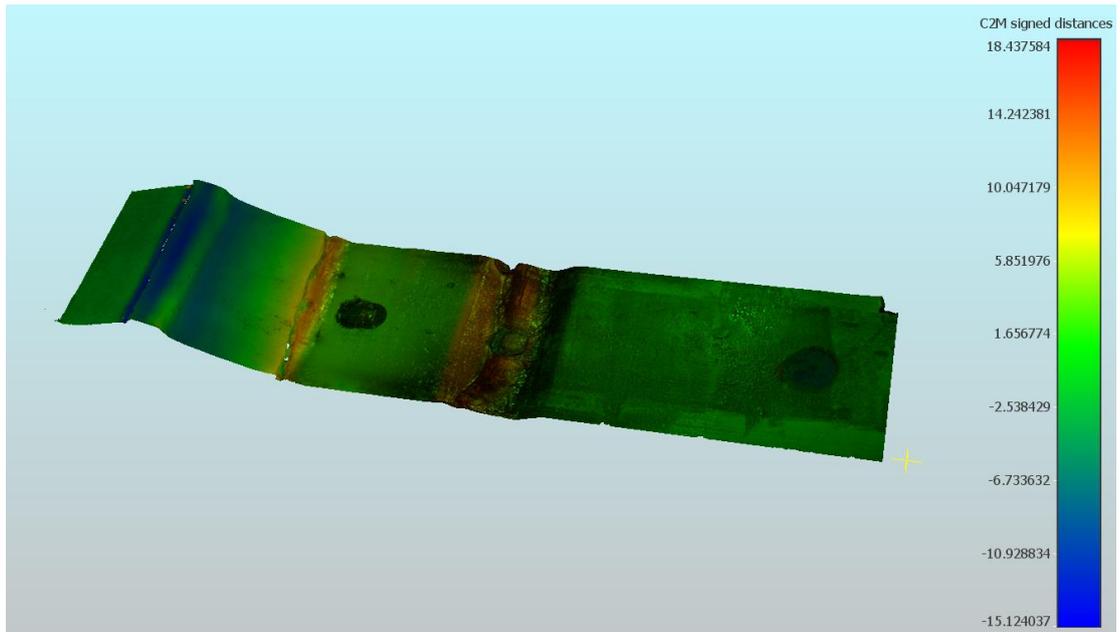
Figure 9.17 clearly shows upward vertical displacement at the toe and ditch bottom.

Figure 9.17 Laser scan of dike body with clay layer after failure of the dike. Distance [mm] computed in reference to the dike before failure. Blue shows settlement (at the crest) and red shows upward displacement (at the toe).

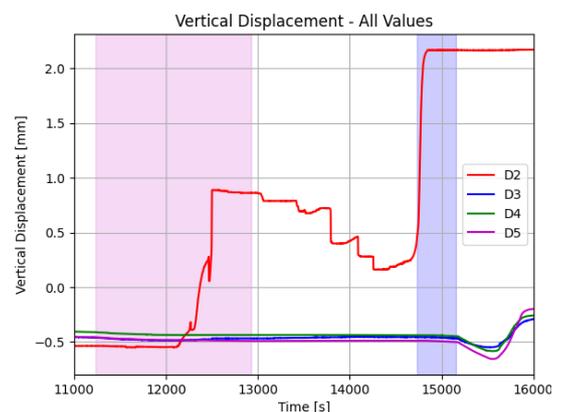
Figure 10.8 Vertical displacement during uplift and failure.

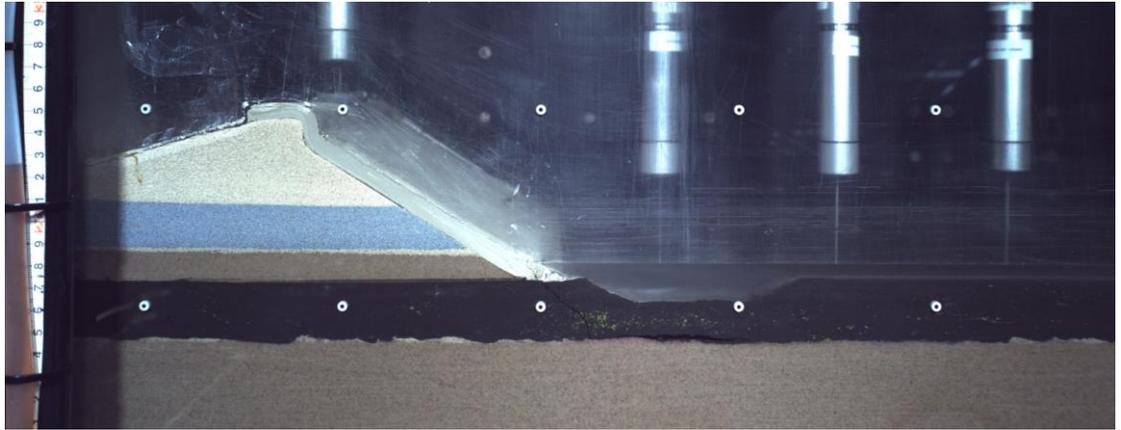
Figure 10.9: Maximum uplift of the clay cover layer.

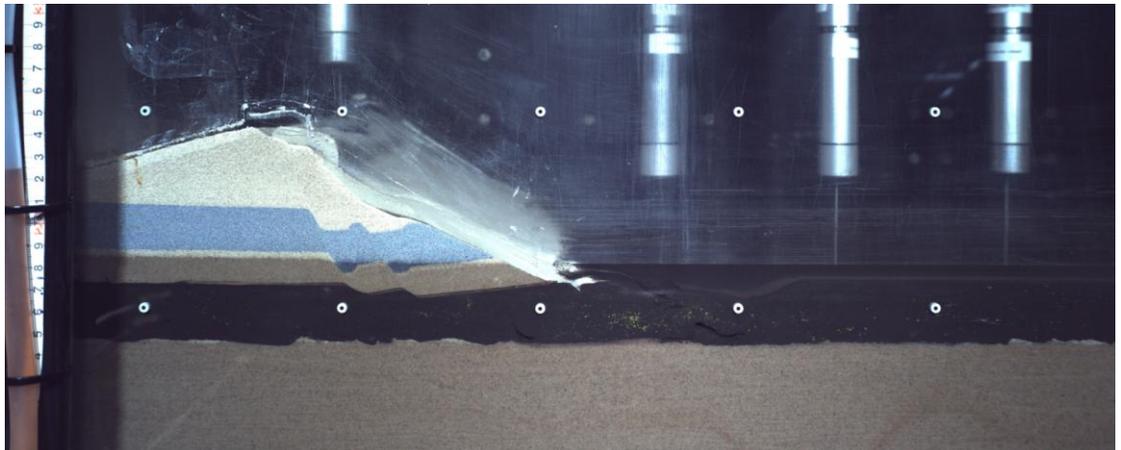
Figure 10.10 Failure of the dike body during the experiment.

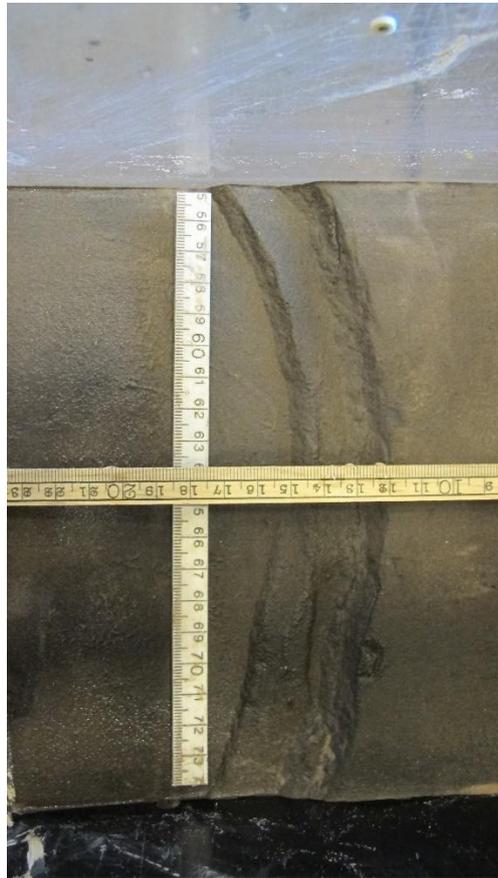
Figure 10.11 Sliding planes visible in the clay after excavation of the sand dike.

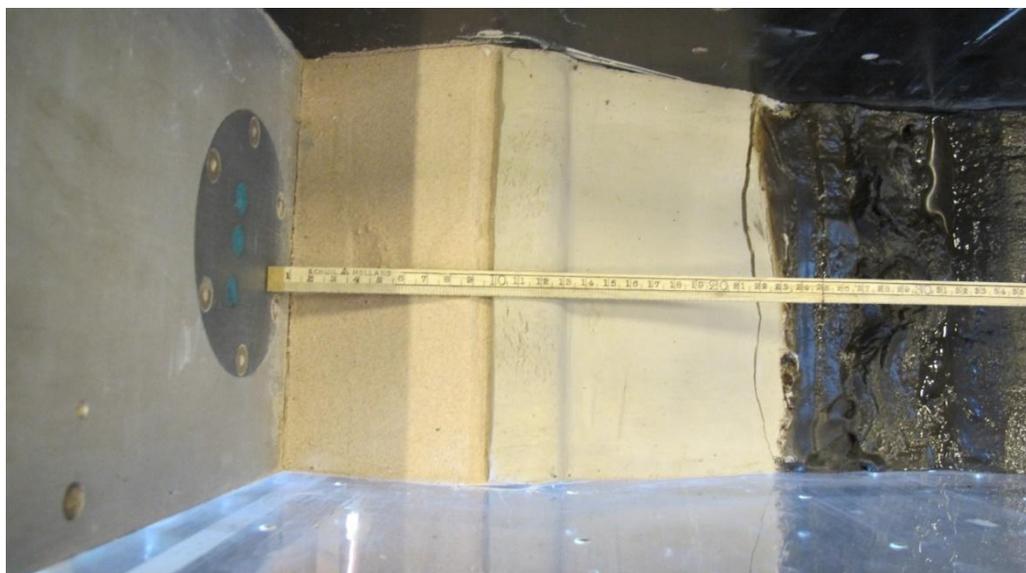
Figure 10.13 Top view of dike after failure, after taking off the fingerling clay layer. The deformed ditch is visible on the right side.
