Impact ditch on dike stability during uplift

Factual report centrifuge tests

Client	SITO Moonshot 2
Contact	Ap van Dongeren
Reference	-
Keywords	Dike stability, uplift, centrifuge testing

Version	1.1
Date	23-01-2025
Project nr.	11210298-020
Document ID	11210298-020-GEO-0002
Pages	82
Classification	Public
Status	Final

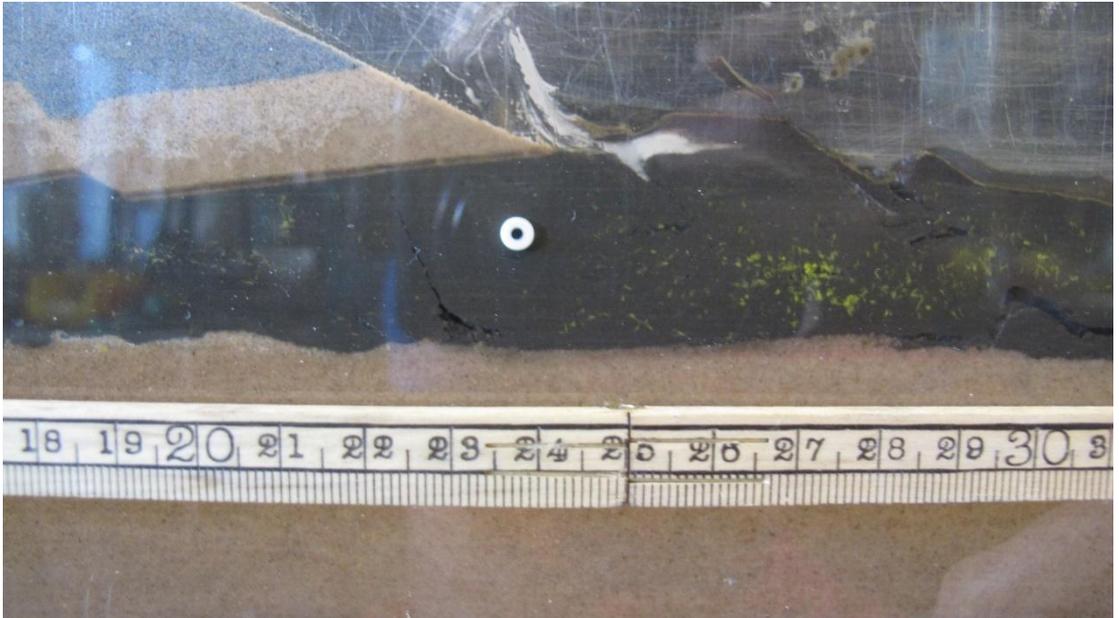
Figure 10.14 Side view of dike toe after failure. Diagonal crack has partially been pressed closed.

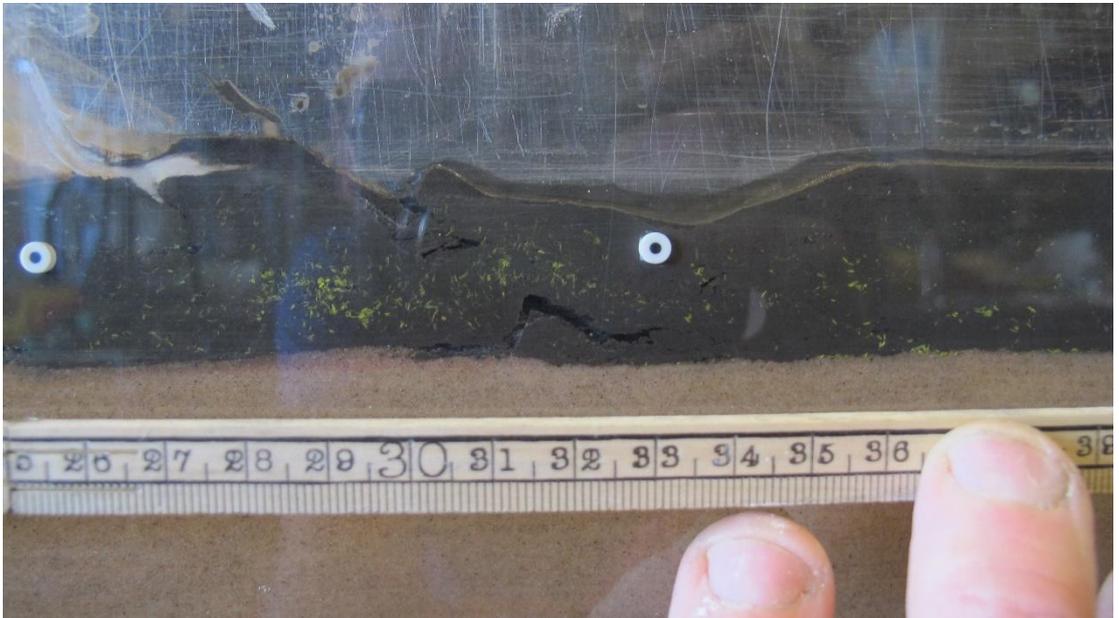
Figure 10.15 Side view of ditch after failure. Lateral crack along the bottom and remnant of diagonal crack on the left side are visible.

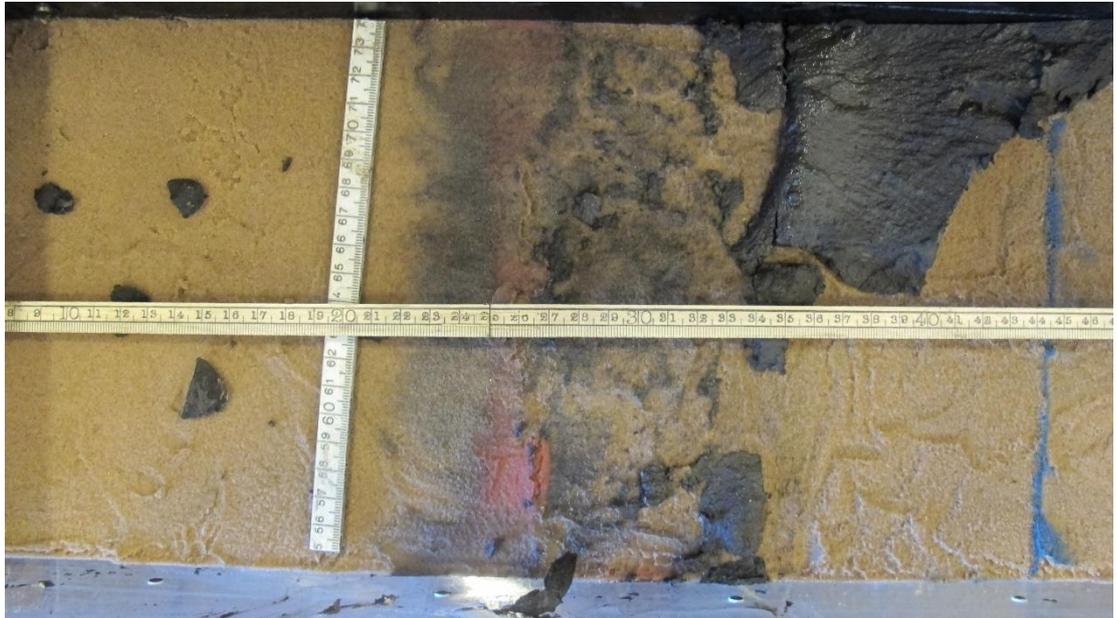
Figure 10.16 Top view of sand layer after removal of dike and cover layer.

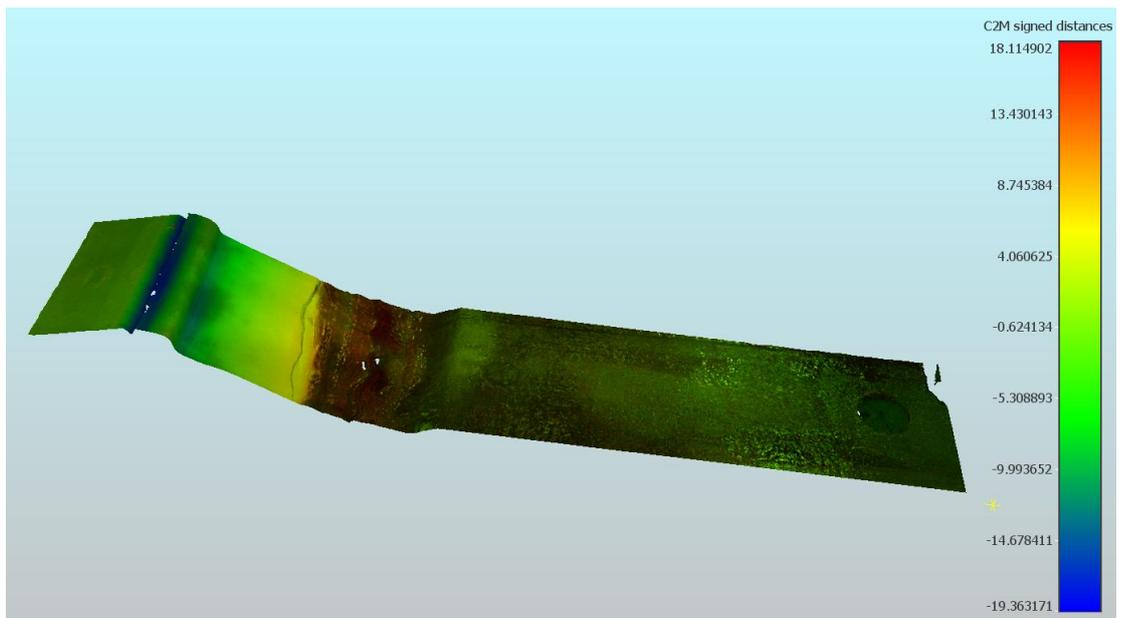
Figure 10.17 Laser scan of dike body with clay layer after failure of the dike. Distance [mm] computed in reference to the dike before failure. Blue shows settlement (at the crest) and red shows upward displacement (at the toe).

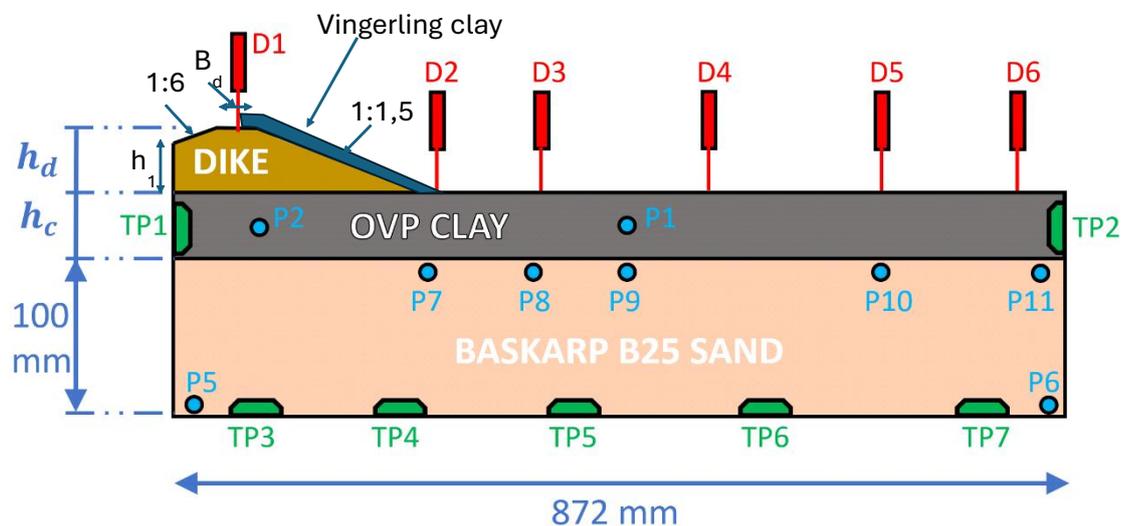
Figure A.1 Sketch geometry.

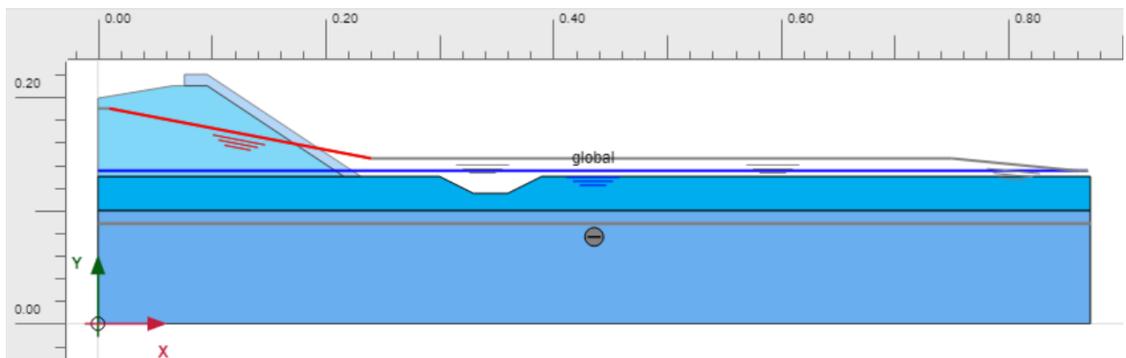
Figure A.2 Schematisation phreatic line and head in sand layer at uplift conditions.

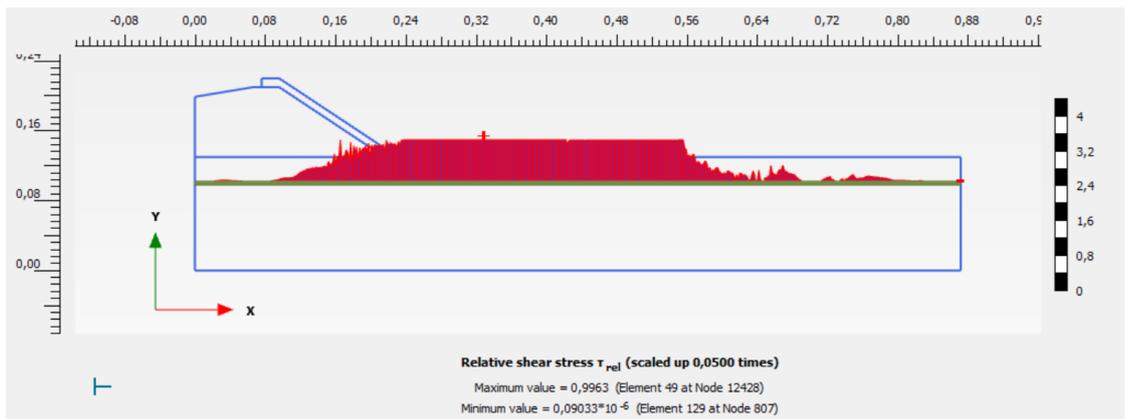
Figure A.21 Relative shear along the interface benchmark calculation.

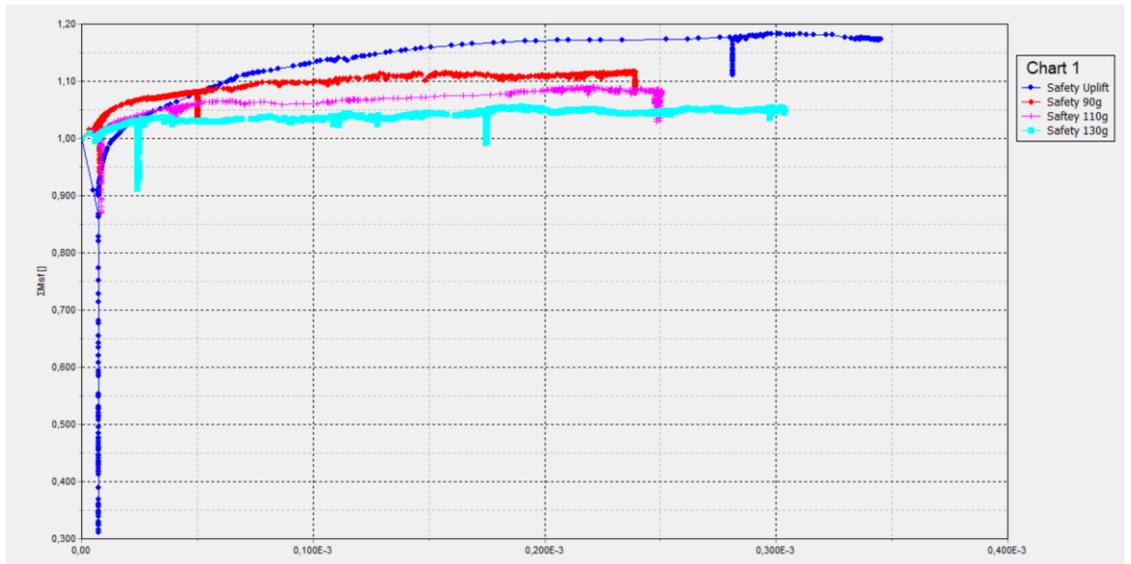
Figure A.22 Safety factor of basis model.

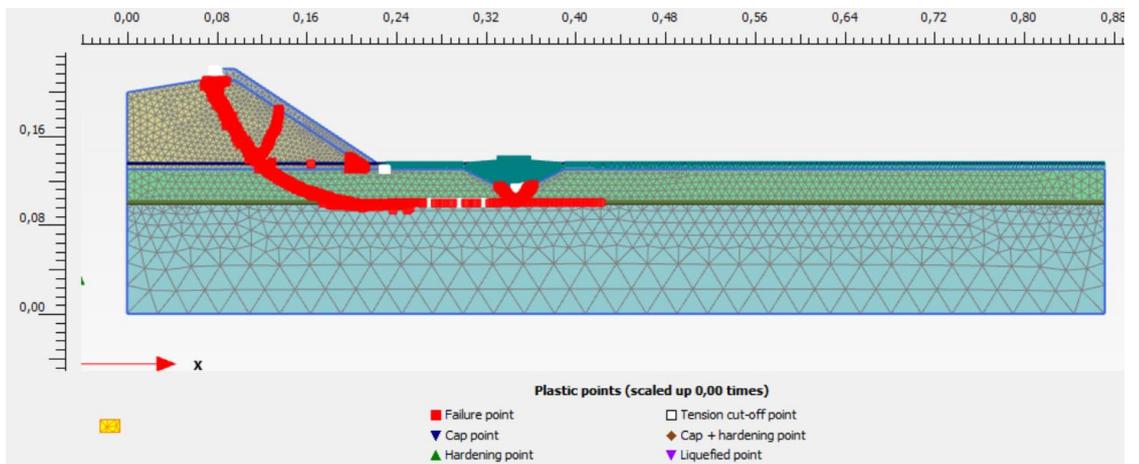
Figure A.23 Impression failure mechanism found after c' - ϕ' reduction at uplift; Plastic points.

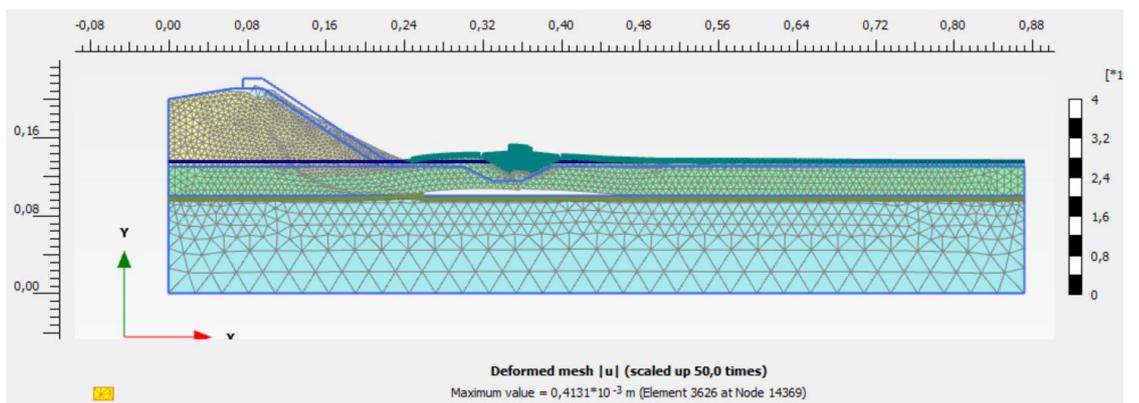
Figure A.24 Impression failure mechanism found after c' - ϕ' reduction when reaching 90g; deformed mesh.

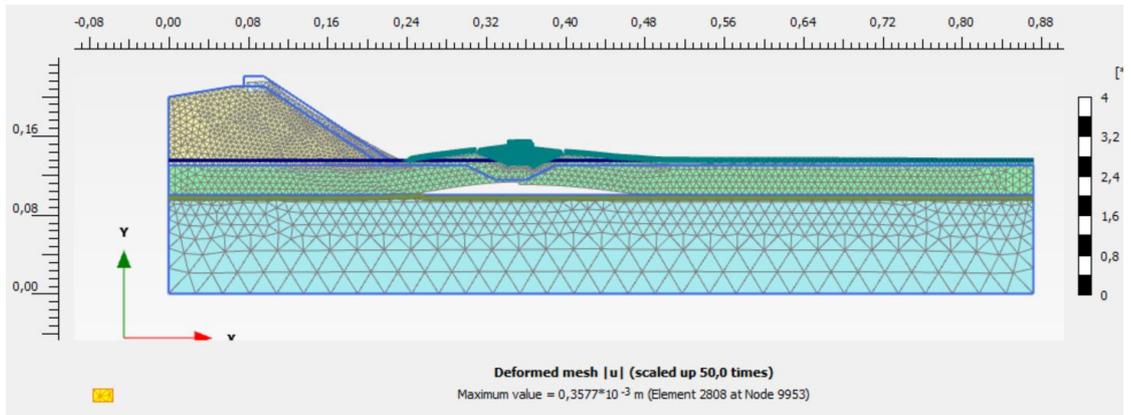
Figure A.25 Impression failure mechanism found after c' - ϕ' reduction when reaching 110g; deformed mesh.

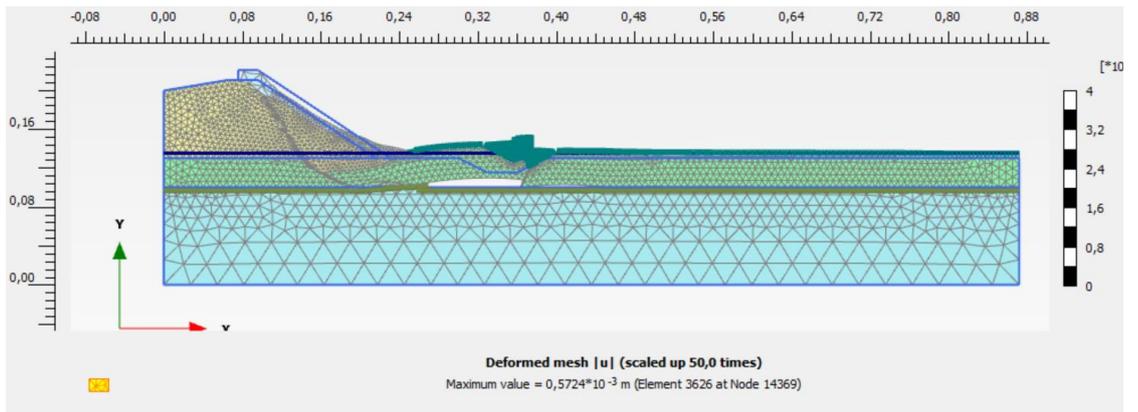
Figure A.26 Impression failure mechanism found after c' - ϕ' reduction when reaching 130g; deformed mesh.

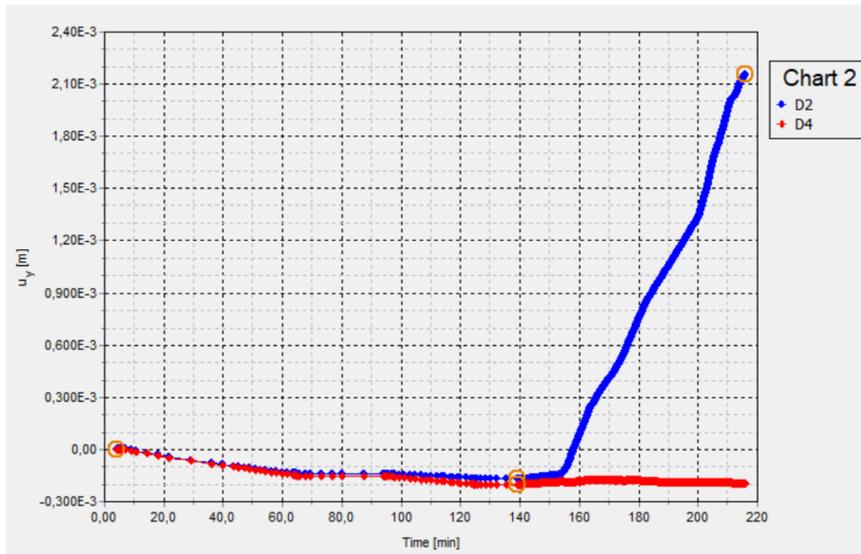
Figure A.27 The vertical displacement at sensor locations D2, at the toe of the dike and D4, polder side of the ditch.

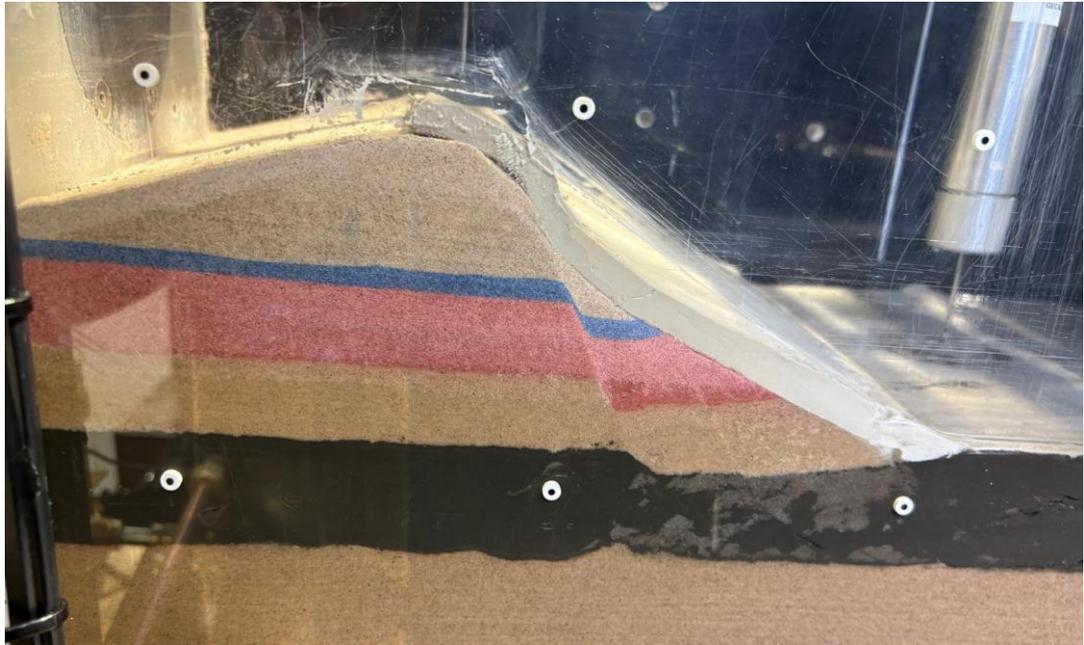
Figure A.29 Failure of test 01.

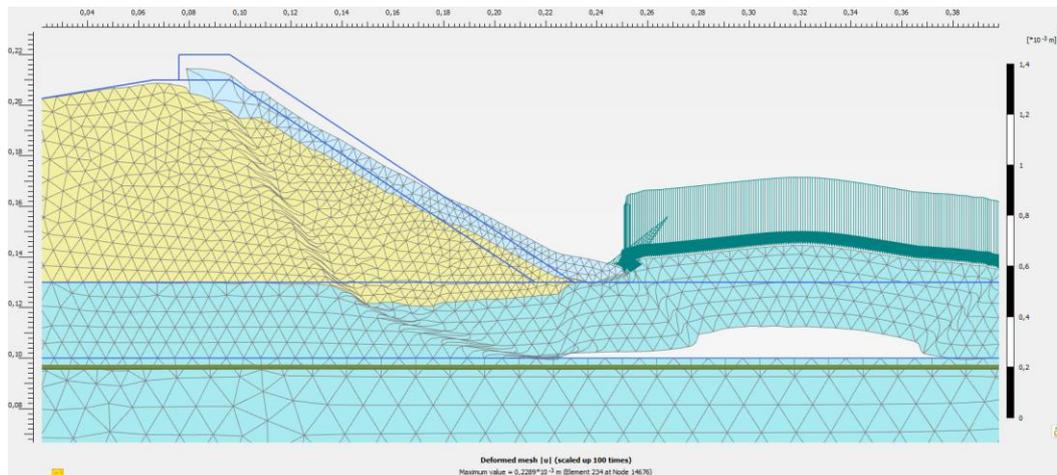
Figure A.30 Deformation after phase safety 110g.

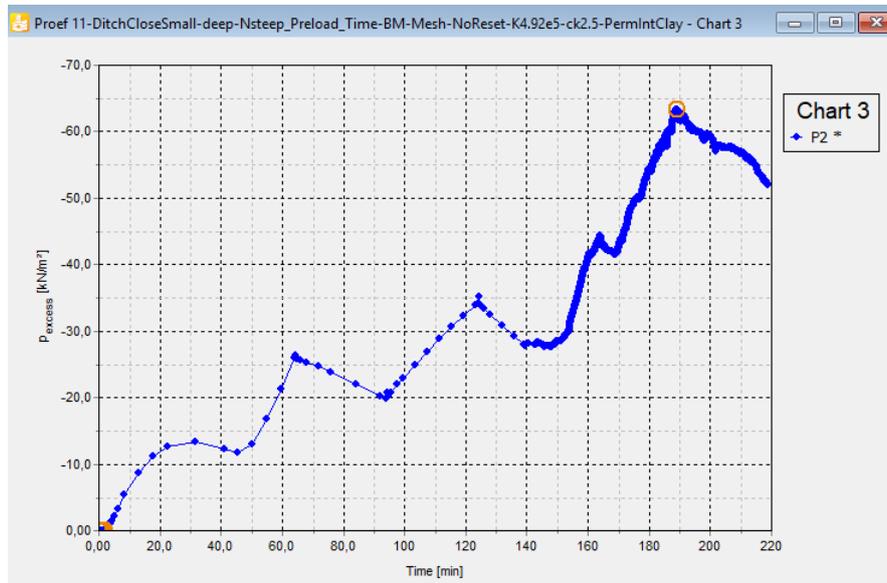
Figure A.32 Calculated pore water pressure at location of P2.

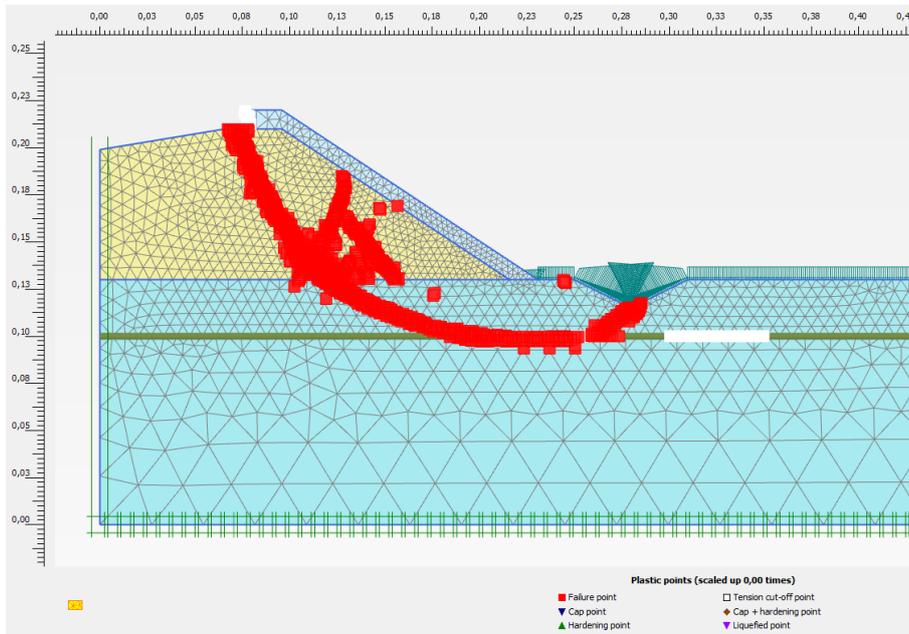
Figure A.33 Plastic points after uplift safety phase, $SF = 0.99$.

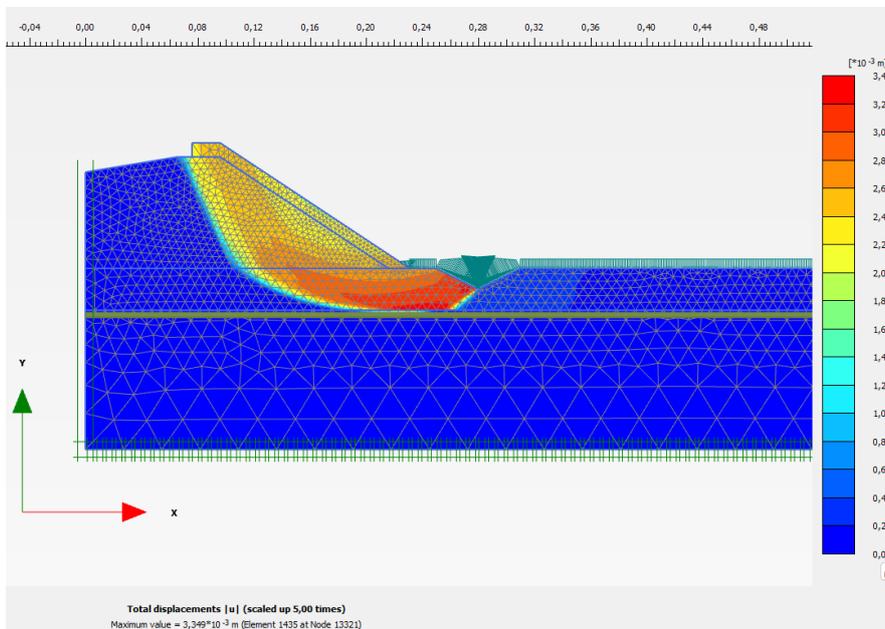
Figure A.34 Deformation after uplift safety phase (scaled), $SF = 0.99$.

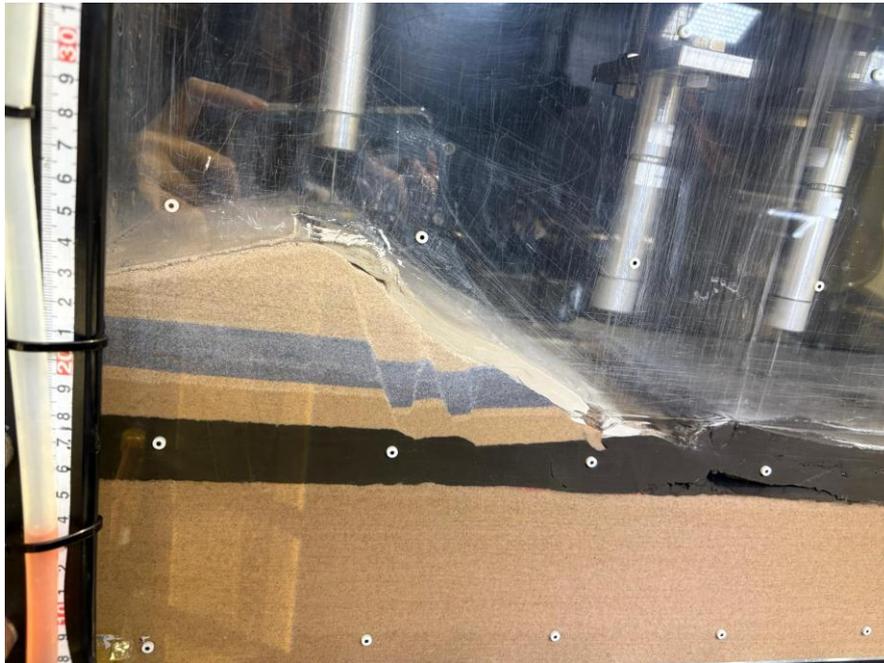
Figure A.35 Observed failure of test 04.

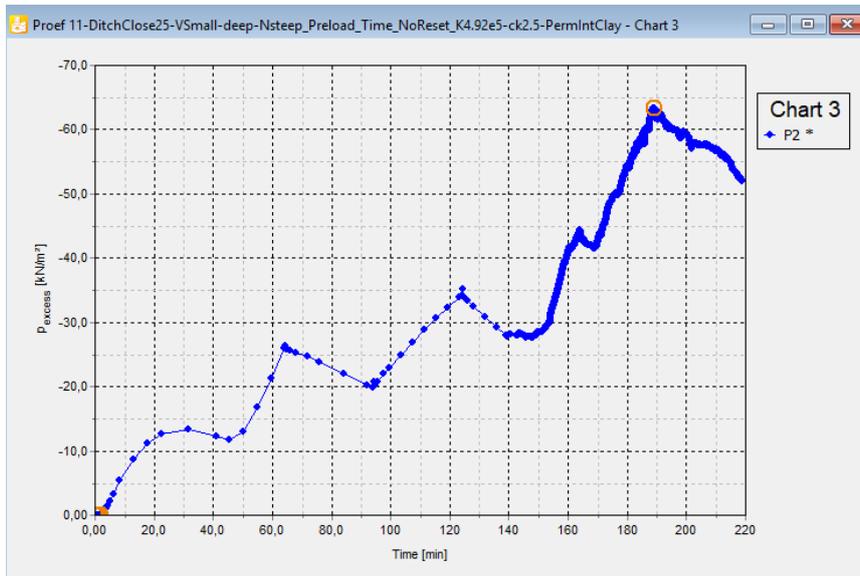
Figure A.36 Pore water pressure at location of P2.

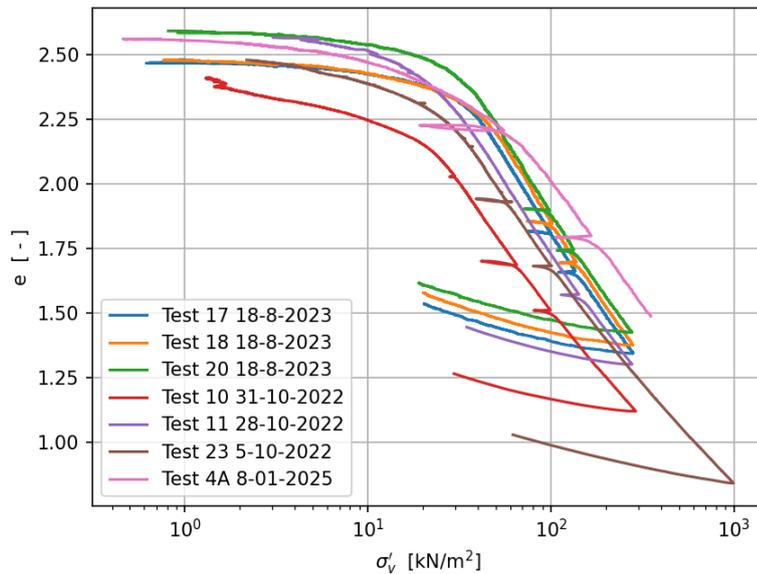
Figure B.1 Comparison stress – void ratio curves CRS tests.

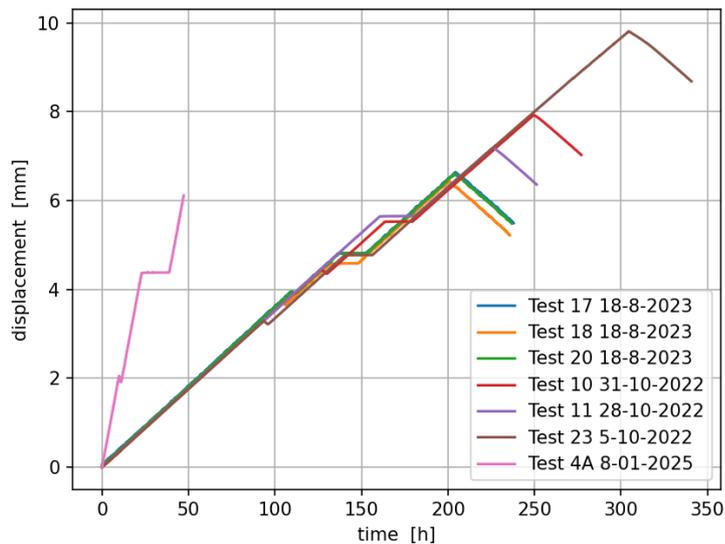
Figure B.2 CRS test results, applied displacement vs time in hours.

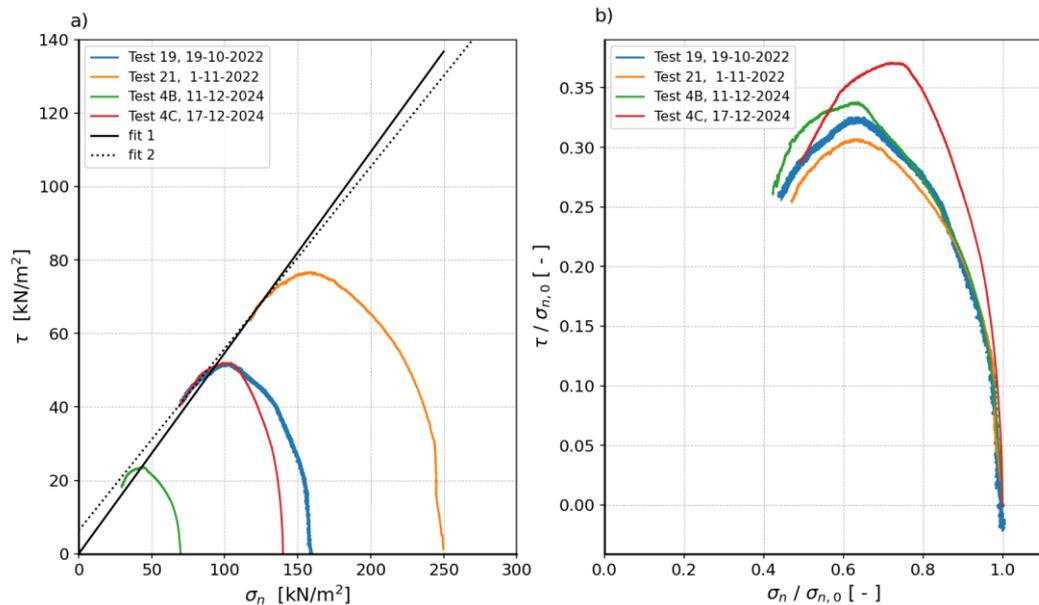
Figure B.4 DSS test results a) stress paths; fit 1 fits result Test 21 without cohesion, fit 2 fits test 19 and 21 b) stress paths normalised for initial normal stress, $\sigma_{n,0}$.

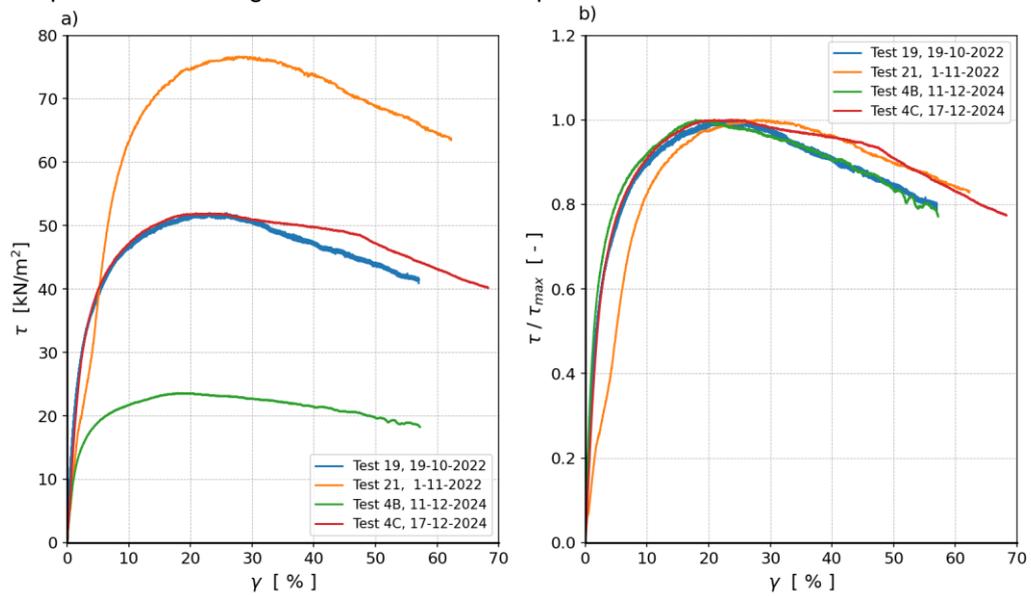
Figure B.5 DSS test results, stress – strain curves a) without normalisation, b) normalised for maximum shear stress, τ_{max} .
