EMERGENCY ADVICE FOR A TEMPORARY DAM NEAR GRAVE

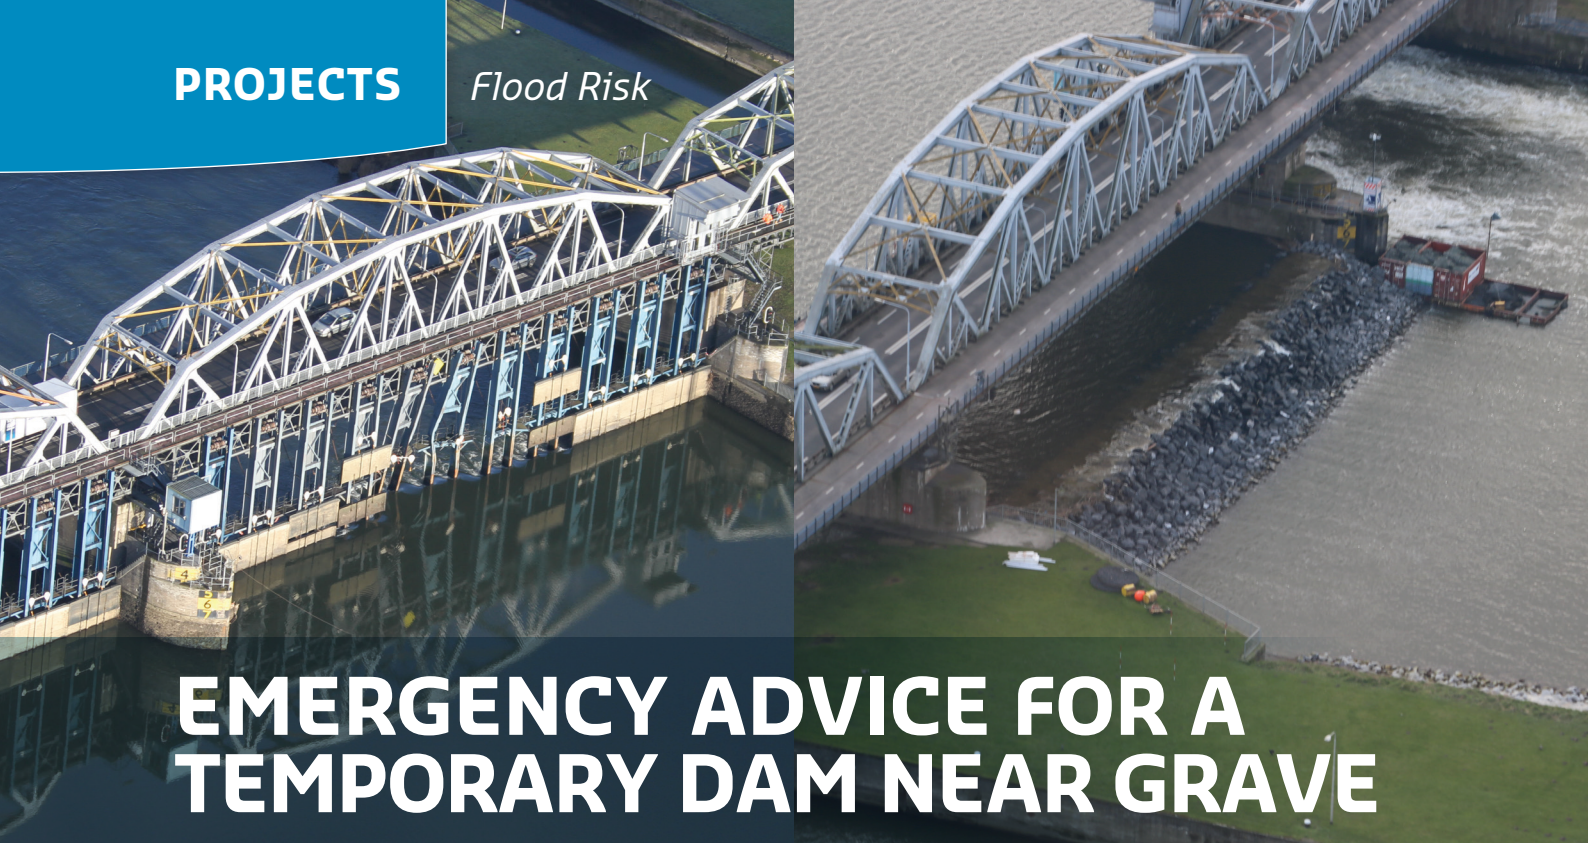
Left: The damage to the weir near Grave, right: Temporary dam structure
